OCULAR INSPECTION CHECKLIST

2. **School Name:** Margarita Janer Palacios

3. **Date of inspection:** Monday , February 10 - 2020

ANEJO A

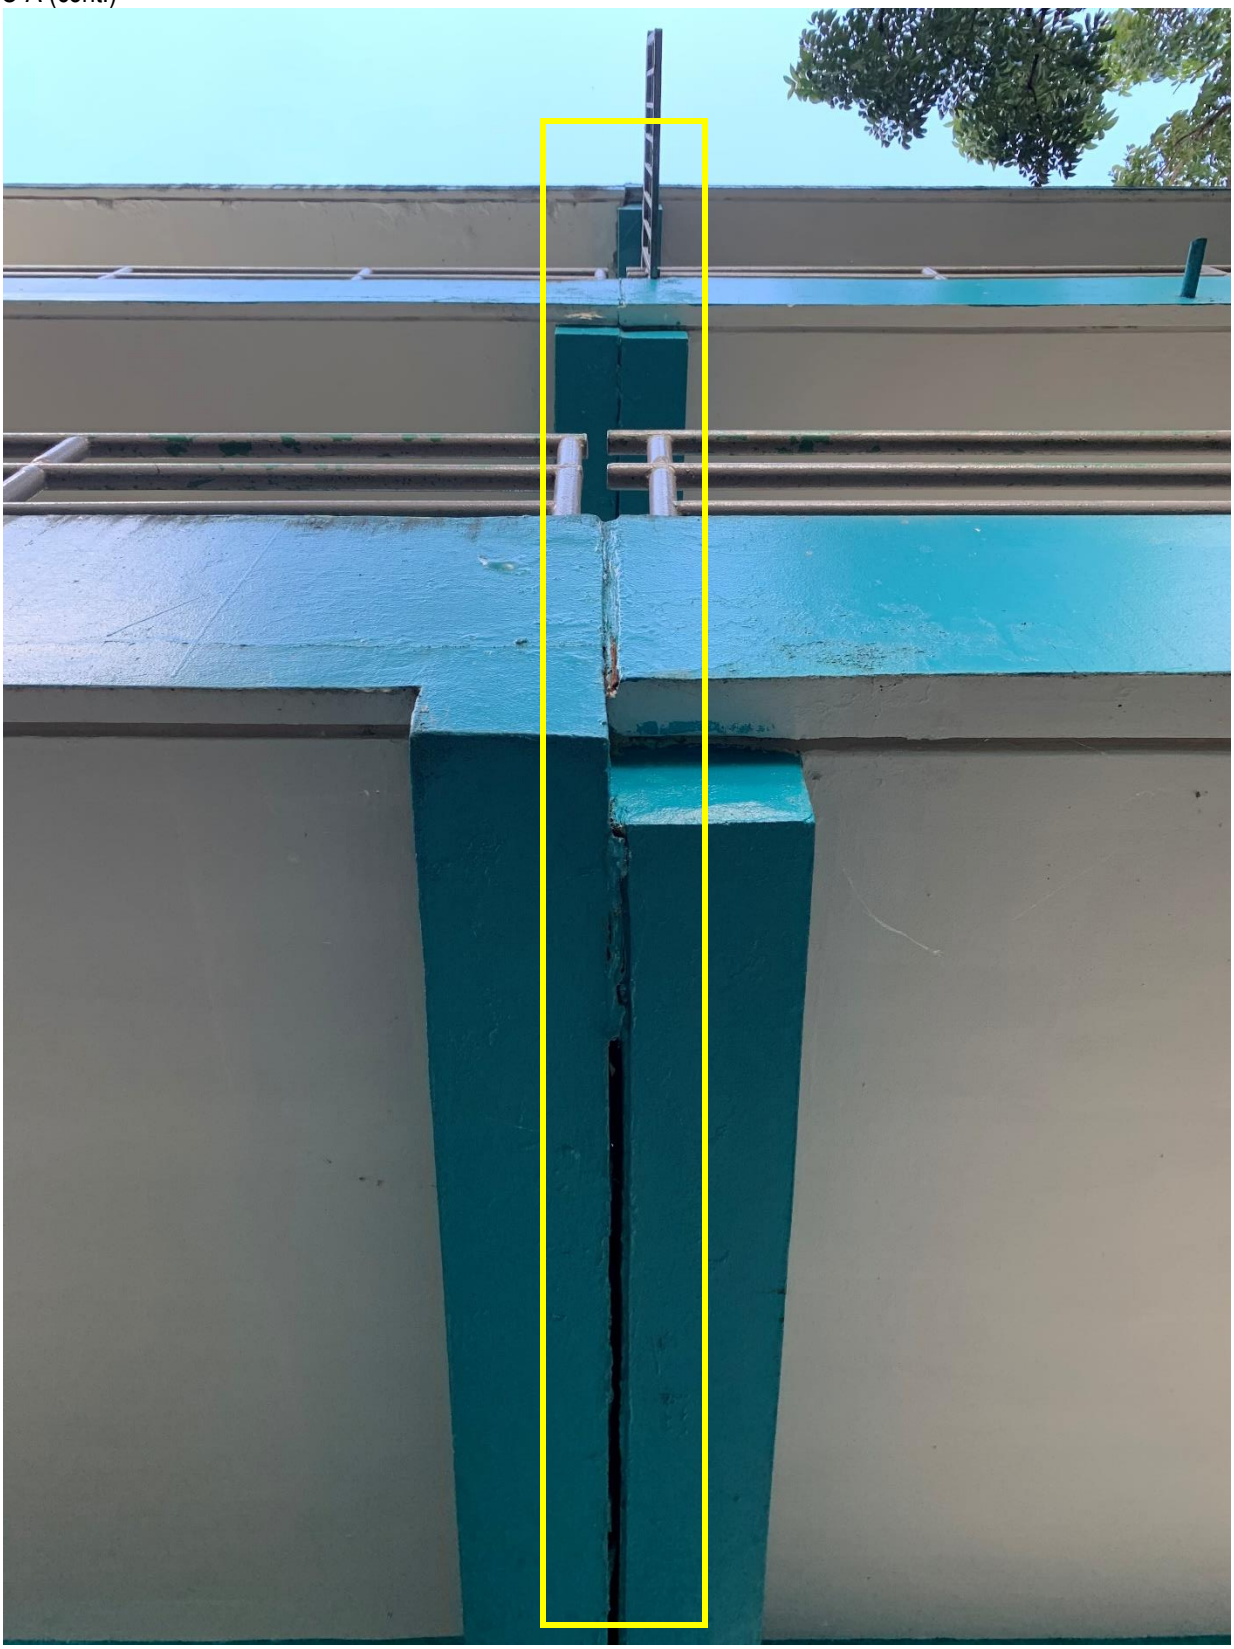
Junta de Construcción en Edificio de 4 niveles.

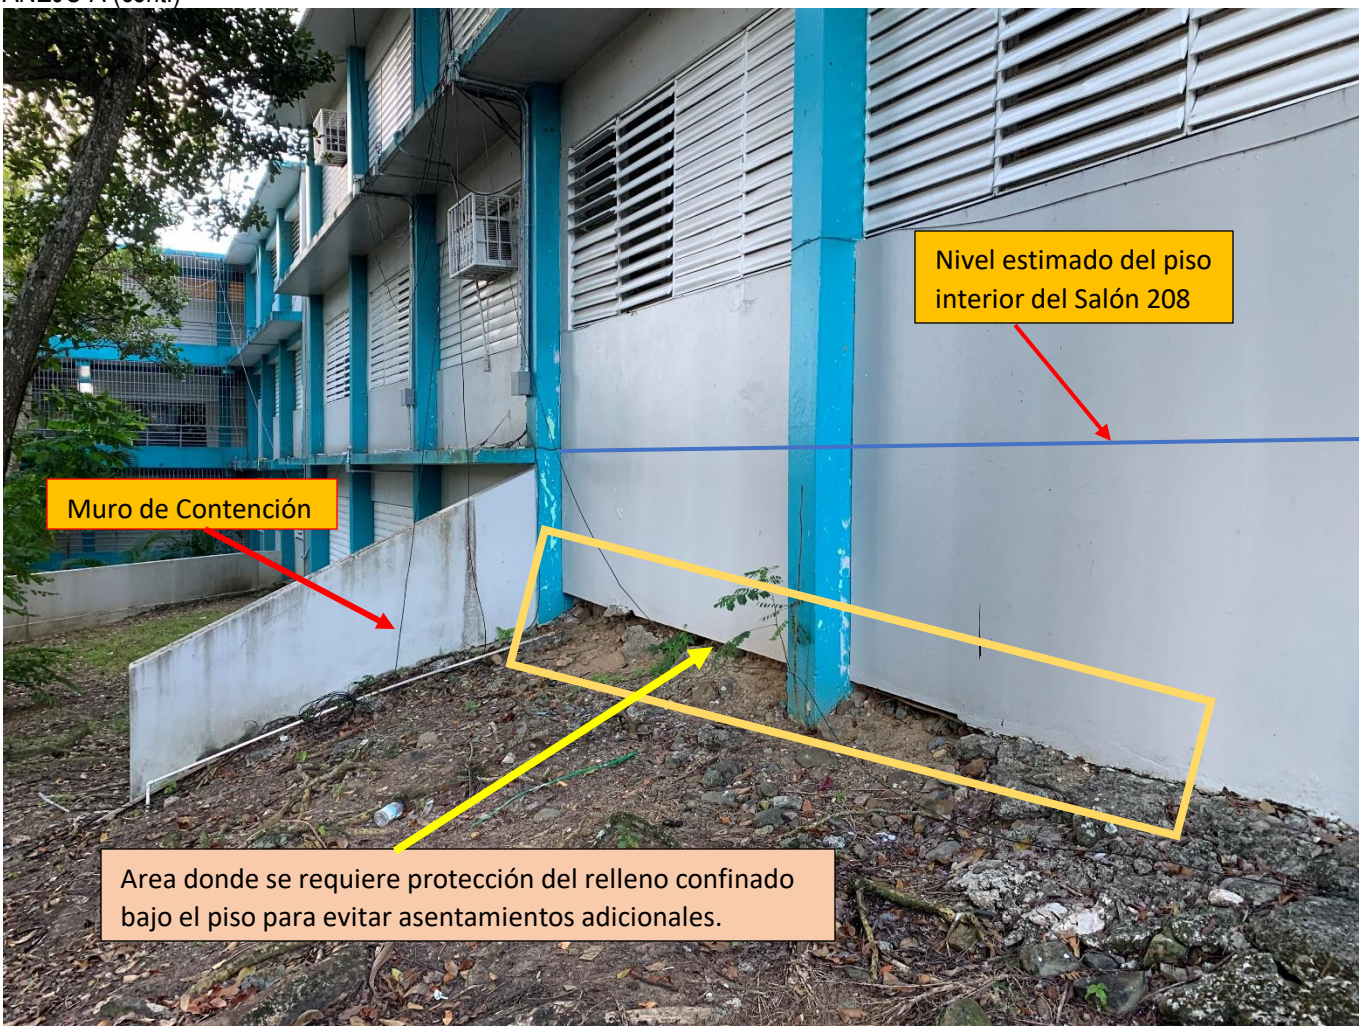
4- Asentamiento y grieta en piso del Salón 208 del Edificio de 4 pisos. Este salón se construyó sobre el terreno en una transición con un muro de contención que divide este salón de otros en un piso inferior. Una visita en detalles al exterior del edificio mostro que existe desde algun tiempo un desplazamiento del material de relleno que se colocó como base para la construcción del piso sobre el terreno. Con la sedimentación de los suelos y el desgaste natural de la proteccion mecanica de este relleno, el mismo ha comenzado a salir poco a poco de la base rellenada. Las reices de arboles cercanos han desplazado la protección que esta área tenia permitiendo que parte del terreno comience a salir del area confinamiento del piso del salón. Actualmente el suelo de ha asentado cerca de una pulgada de su posicion original y la pared de bloque cercana a ese piso muestra algunas grietas prodeucto del asentamiento. Este asentamiento es previo a los eventos telúricos pero al momento no representa peligro a la capacidad estructural del edificio ni compromete al edificio. Se recomienda que se cubra y proteja el área expuesta de relleno para evitar que se continue erosionando el área.

Area exterior del Salón 208 Edificio de 4 niveles donde se requiere protección del relleno confinado bajo la loza structural de piso para evitar asentamientos adicionales en el piso y grietas adicionales.
