## CARTA DE TRAMITE

Escuela: **Esperanza González**

Código: **(12260)**

## OCULAR INSPECTION CHECKLIST

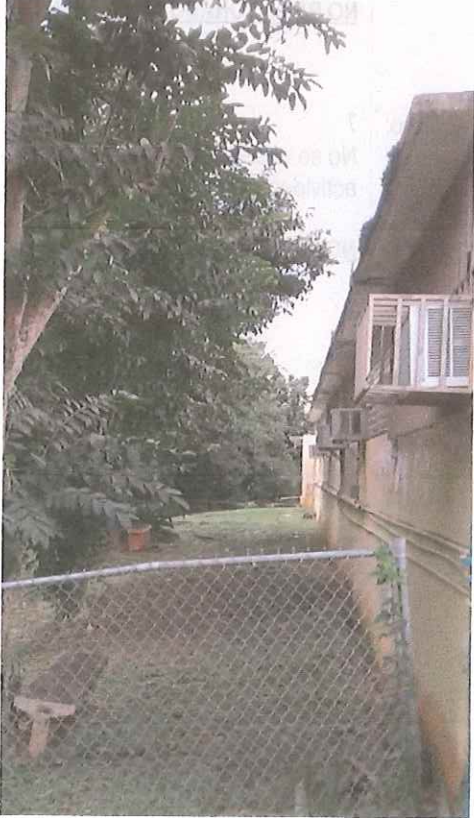
A photograph showing a paved concrete walkway leading from a grassy area towards a building with a white door and a blue structure. There are trees and foliage on the left side.
<p>Area: Exteriores</p> <p>Se revisaron todos los alrededores de las facilidades sin encontrar rasgos de fallas por causa del terremoto. Los gazebos, tanques de gas, pozo séptico y demás áreas misceláneas no observaron daños.</p> <p><b><u>NO RELACIONADO AL EVENTO SISMICO</u></b></p>
