OCULAR INSPECTION CHECKLIST

1. **Street Address of the School:** Carr. 155, Km. 34, Hm. 1 Bo. Gato
- City:** Orocovis **State:** Puerto Rico **Zip:** 00720
2. **School Name:** Visitación Paqán Aponte
3. **Date of inspection:** January 15, 2020
4. **Inspector's Name:** Edgardo Hernández-Alvarado

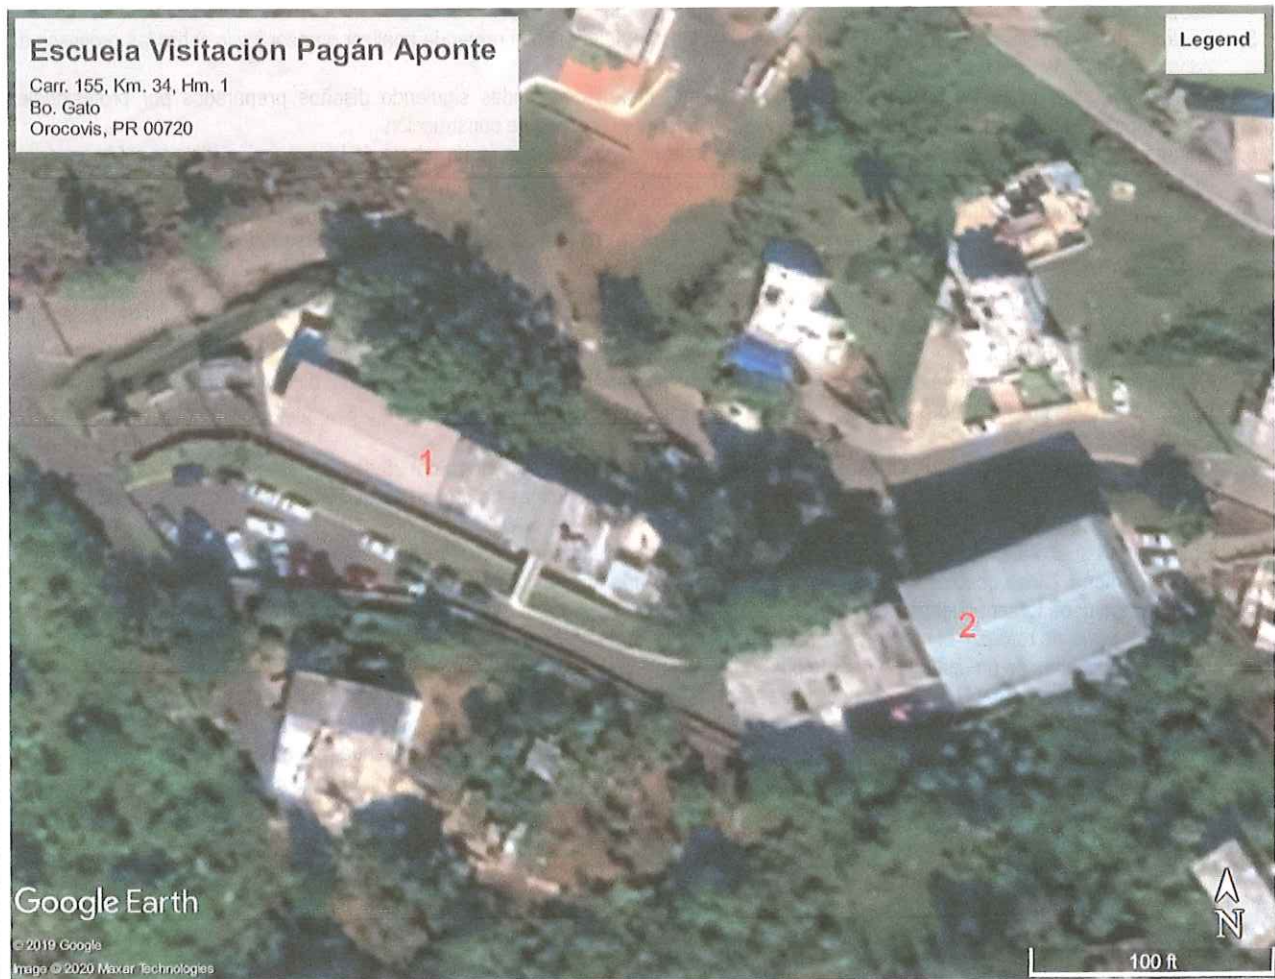
Plano de Sitio	Visitación Pagán Aponte
Descripción:	Predio rural con aproximadamente 4,800 m ² . Dos (2) estructuras independientes con aproximadamente 22,500 pies cuadrados de área bruta de piso.
