CARTA DE TRAMITE

Escuela: BA Miguel A. Julia Collazo

Municipio: Cayey

OCULAR INSPECTION CHECKLIST

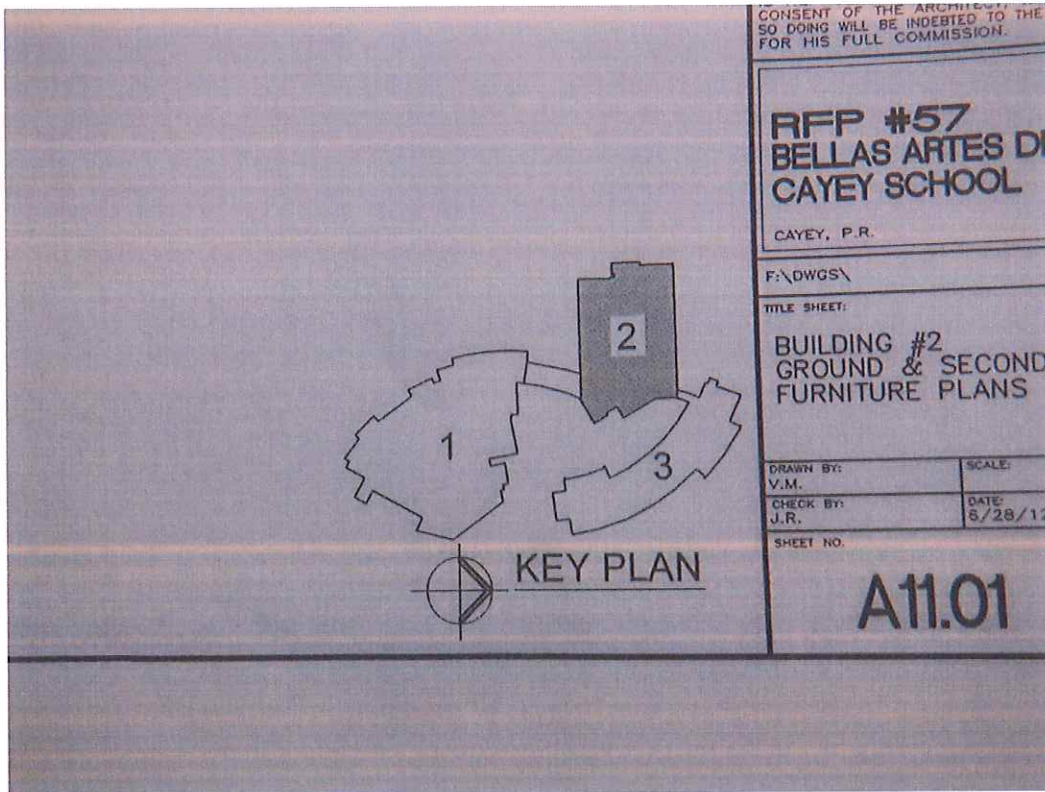
| Plano de Sitio | Nombre de Escuela Bellas Artes, Miguel A. Julia Collazo |

| Descripción: | Vista aérea de la escuela / Plano de planta de escuela para identificar las áreas evaluadas. |
