CARTA DE TRAMITE

Escuela: Luis Muñoz Rivera

Municipio: Las Piedras

OCULAR INSPECTION CHECKLIST

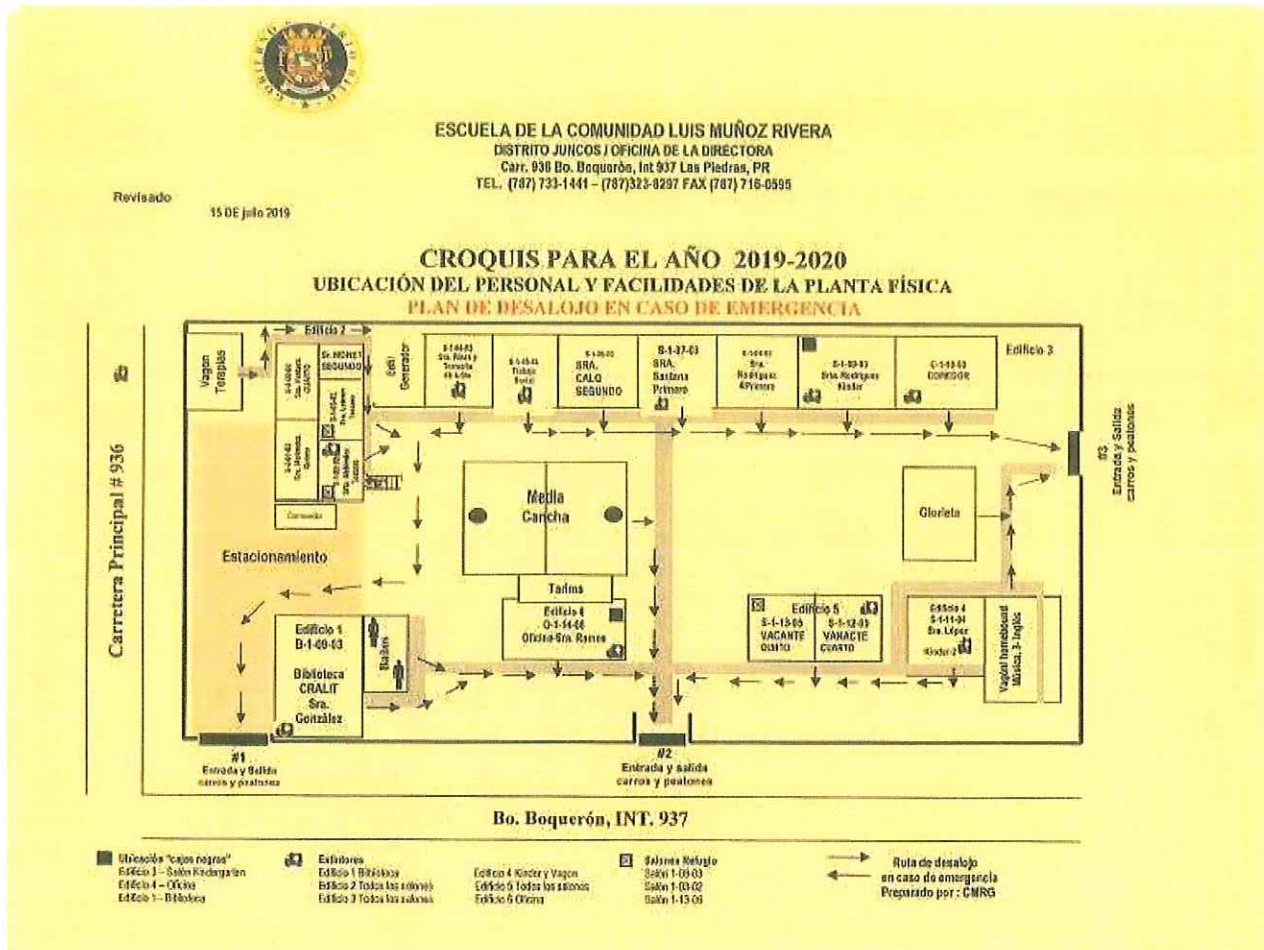
Plano de Sitio

Descripción: Vista aérea de la escuela / Plano de planta de escuela para identificar las áreas evaluadas.
