CARTA DE TRAMITE

Escuela: Cotto Anexo

Código: (10173)

OCULAR INSPECTION CHECKLIST

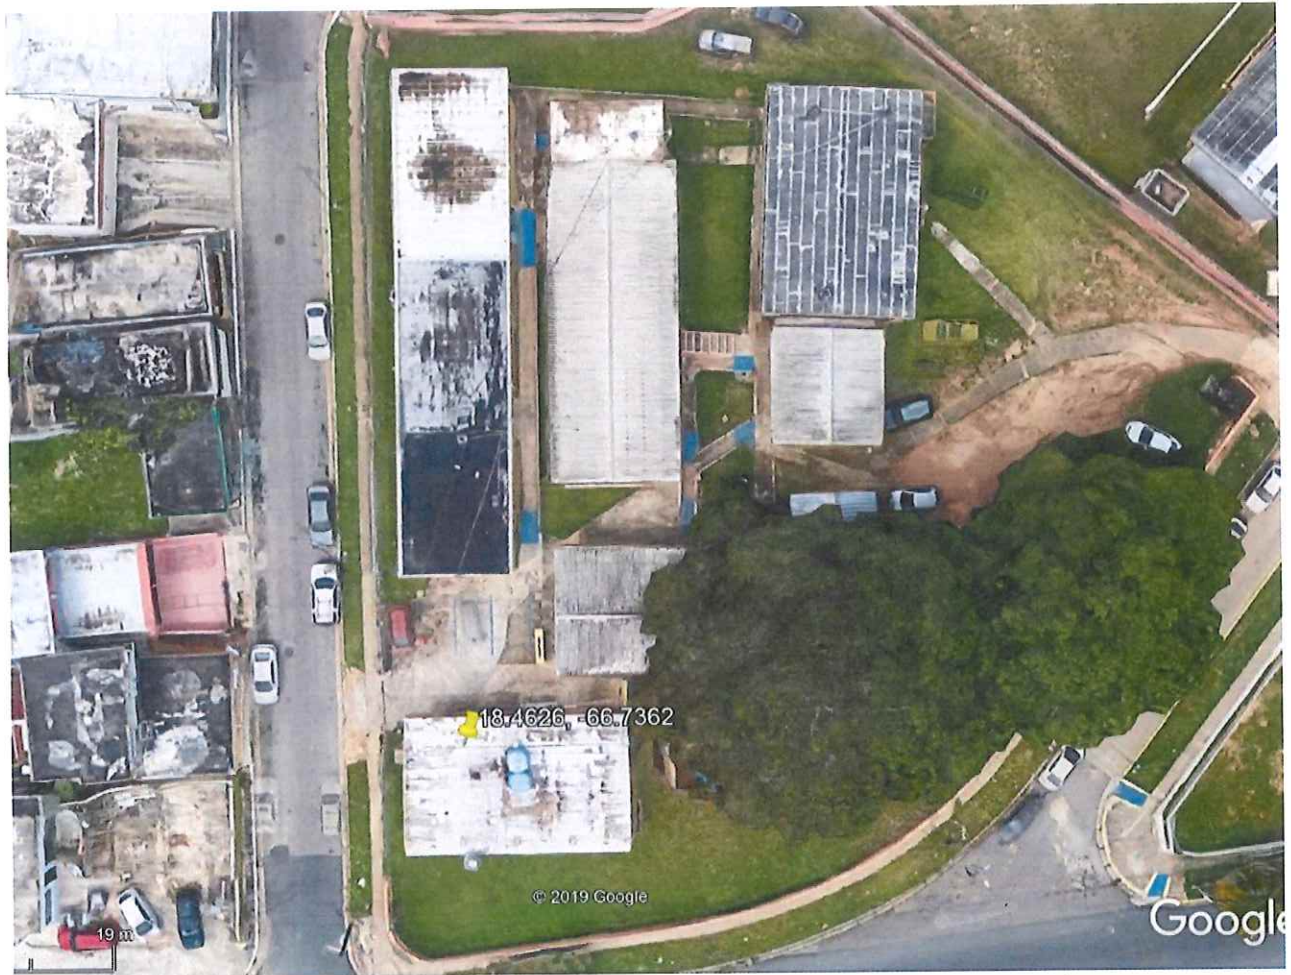
Plano de Sitio	Nombre de Escuela
Descripción:	Vista aérea de la escuela / Plano de planta de escuela para identificar las áreas evaluadas.
