CARTA DE TRAMITE

Escuela: Víctor Rojas I

Municipio: Arecibo

Fecha de:
Inspección 10-Jan-20

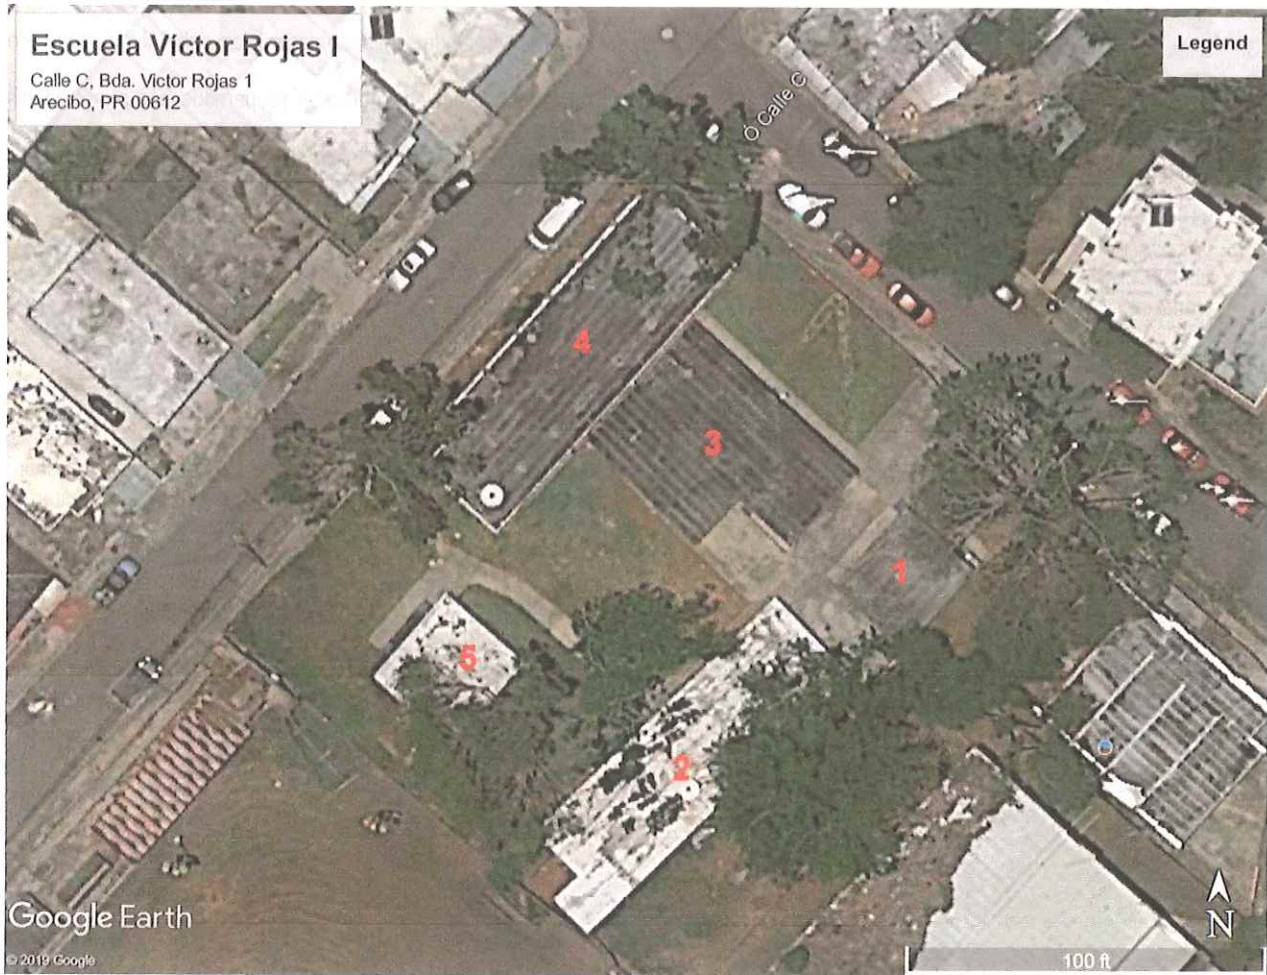
Plano de Sitio	Nombre de Escuela
Descripción:	Predio urbano con aproximadamente 3,000 m ² . Cinco (5) estructuras independientes con aproximadamente 10,500 pies cuadrados de área bruta de piso.
