## OCULAR INSPECTION CHECKLIST

1. Street Address of the School: PR-130
- City: Hatillo State: Puerto Rico Zip: 00659
2. School Name: Luis Muñoz Rivera
3. Date of inspection: January 13, 2020
4. Inspector's Name: Carlos E. Oquendo-Larracuente

### ANEJO A

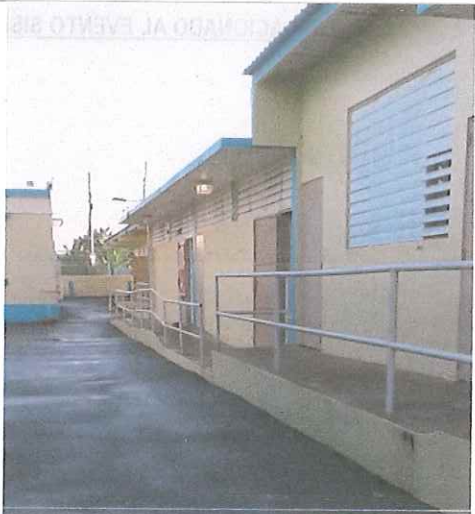
A photograph showing the exterior of a light-colored building with a concrete ramp and metal handrails. The building has a blue roofline. In the background, there are utility poles and other buildings under a clear sky.
<p>Edificio: 9</p>	<p>No se observaron daños relacionados a la actividad sísmica.</p> <p><b><u>NO RELACIONADO AL EVENTO SISMICO</u></b></p>
