## CARTA DE TRAMITE

Escuela: Carmen N. Peraza Toledo (John Whittier) Código: (11411)

Municipio: Hatillo Fecha de: 13-Jan-20  
Inspección

## OCULAR INSPECTION CHECKLIST

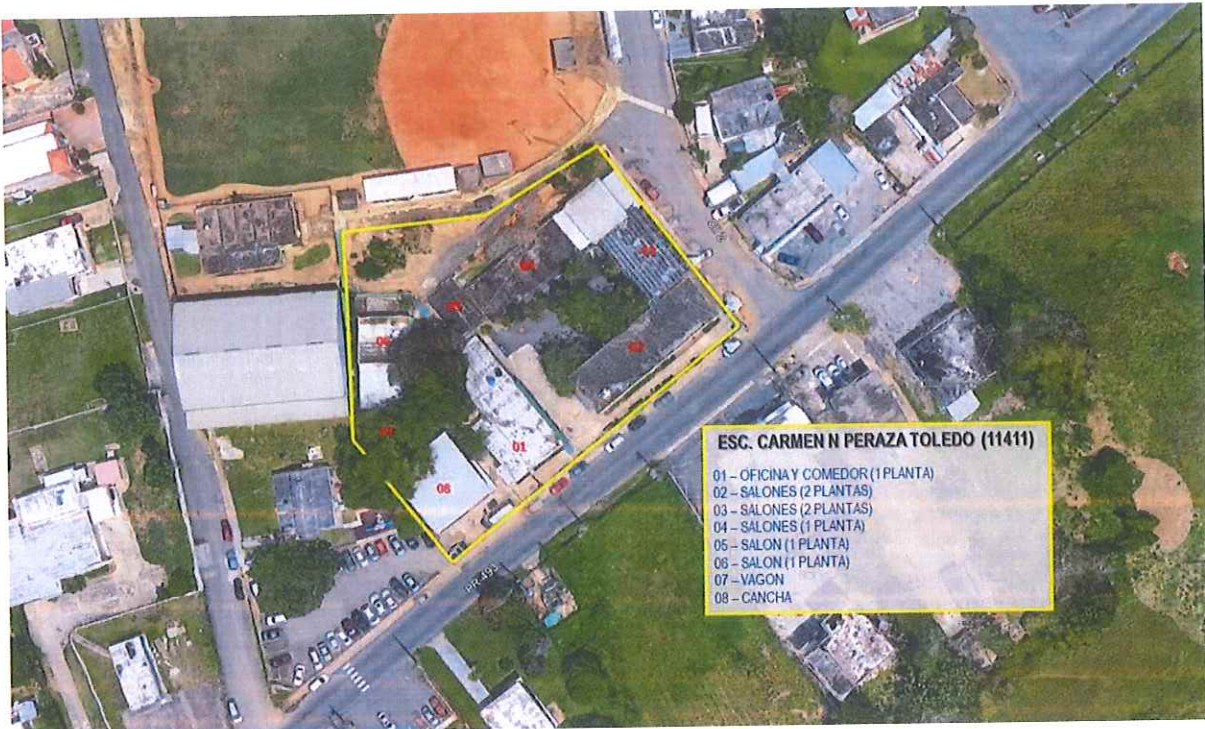
Plano de Sitio: CARMEN N PERAZA TOLEDO (11411)  
Descripción: Vista aérea de la escuela para identificar las áreas evaluadas.
