A.	GENERAL INFORMATION		
1.	Street Address of the School:	PR #10 km. 52.2	
	City: Utuado	State: P.R. Zip:	00641
2.	School Name:	Escuela Superior Vocacional Anton

3.	Date of Inspections	January 10, 2020	
4.	Inspector's Name: Adolfo Bonilla Ro		
B.	BUILDING SITE INSPECTION		
5.			
	Utility Service Safety:		
and to cho	FANT—Immediately following an earthquake, check the entire it, turn off the gas at the meter where it enters the house. Lo gas has been shut off, vacate the building and contact the	ocate and repair leaks before turning one book o	nell of gas. If gas odor is n. If the gas odor persists
IMPORT	TANT-Before entering a damaged, vacant building verify that ther a manual valve or a seismically-activated gas shut-off v	at cas is off. Chack the age meter for damage or	nd position of main gas

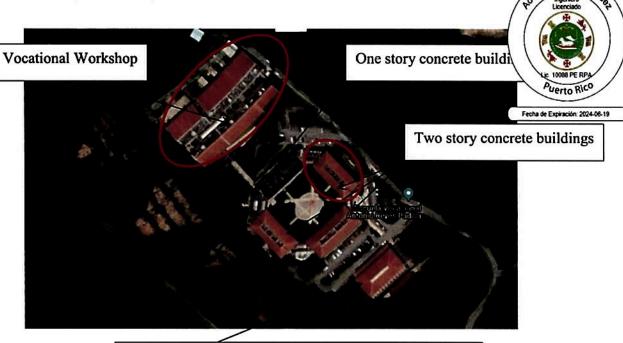
Basketball court - Temporary Police Utuado headquartes

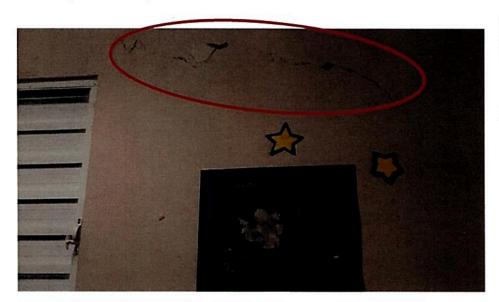
Typical "hair crack" at windows corners in the interior walls

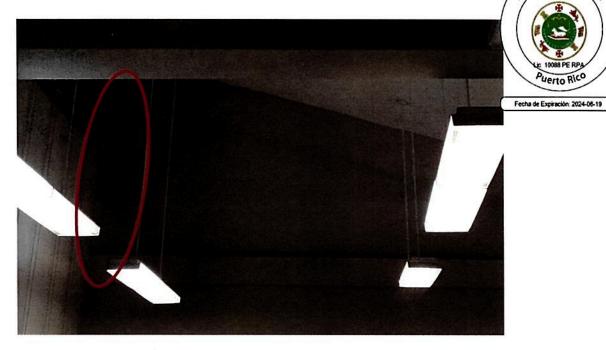
Typical "hair crack" at windows corners in the interior walls. Cement plaster in local areas detached deposited the waste in the floor.
