CARTA DE TRAMITE

Escuela: **Republica de Brasil**

Código: **(61515)**

Informe de inspección ocular de daño en la Escuela República de Brasil
Calle 48 Esq. 9, Reparto Metropolitano , San Juan P.R 00921

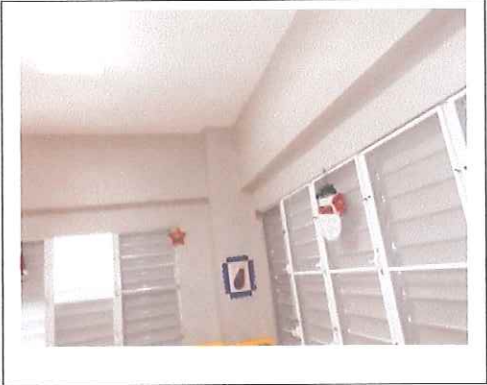
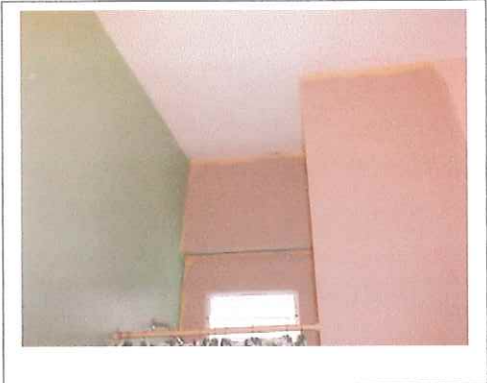
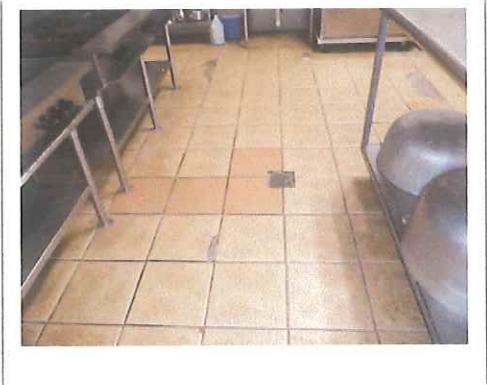
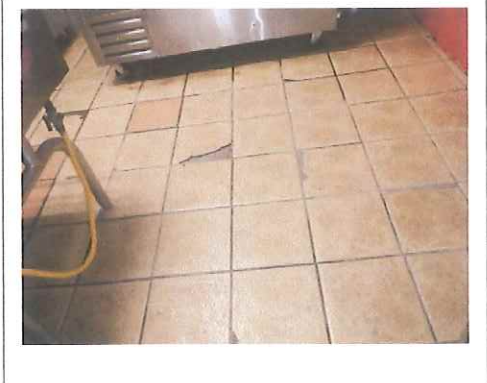
4- Edificio no.4

- 4- Edificio no.4.: Edificio Salones 2 niveles
 - Humedad de agua del techo, no tratado para humedad
 - Grietas y paredes existentes no significativa
- 5- Edificio no.5: Edificio Comedor y almacén
