CARTA DE TRAMITE

Escuela: Imbery Código: (10744)

Municipio: Barceloneta Fecha de: 13-Jan-20
Inspección

OCULAR INSPECTION CHECKLIST

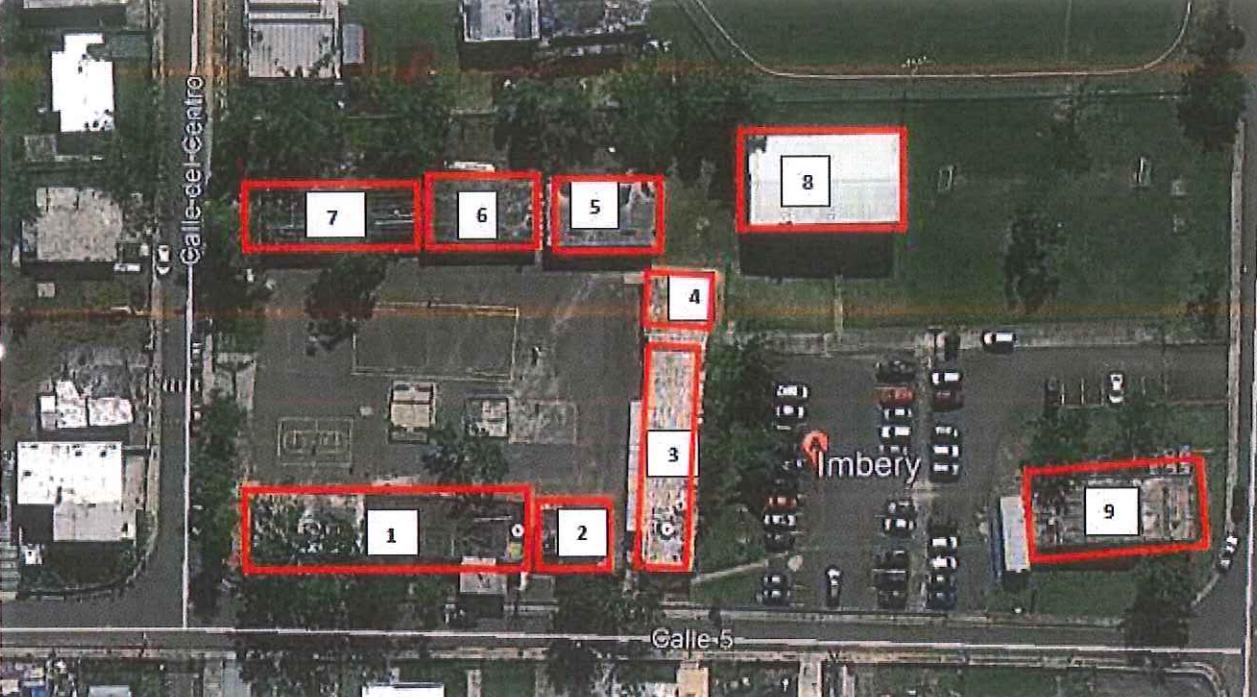
| Plano de Sitio | Imbery |

| Descripción: | Vista aérea de la escuela identificando las estructuras donde se llevó a cabo una inspección visual. |
