OCULAR INSPECTION CHECKLIST

1. **Street Address of the School:** Urb.Villa Serena Calle Orquídea #2
City: Arecibo **State:** Puerto Rico **Zip:** 00613
2. **School Name:** Elba Luqo Carrión
3. **Date of inspection:** January 10, 2020
4. **Inspector's Name:** Edgardo Hernández-Alvarado

ANEJO A

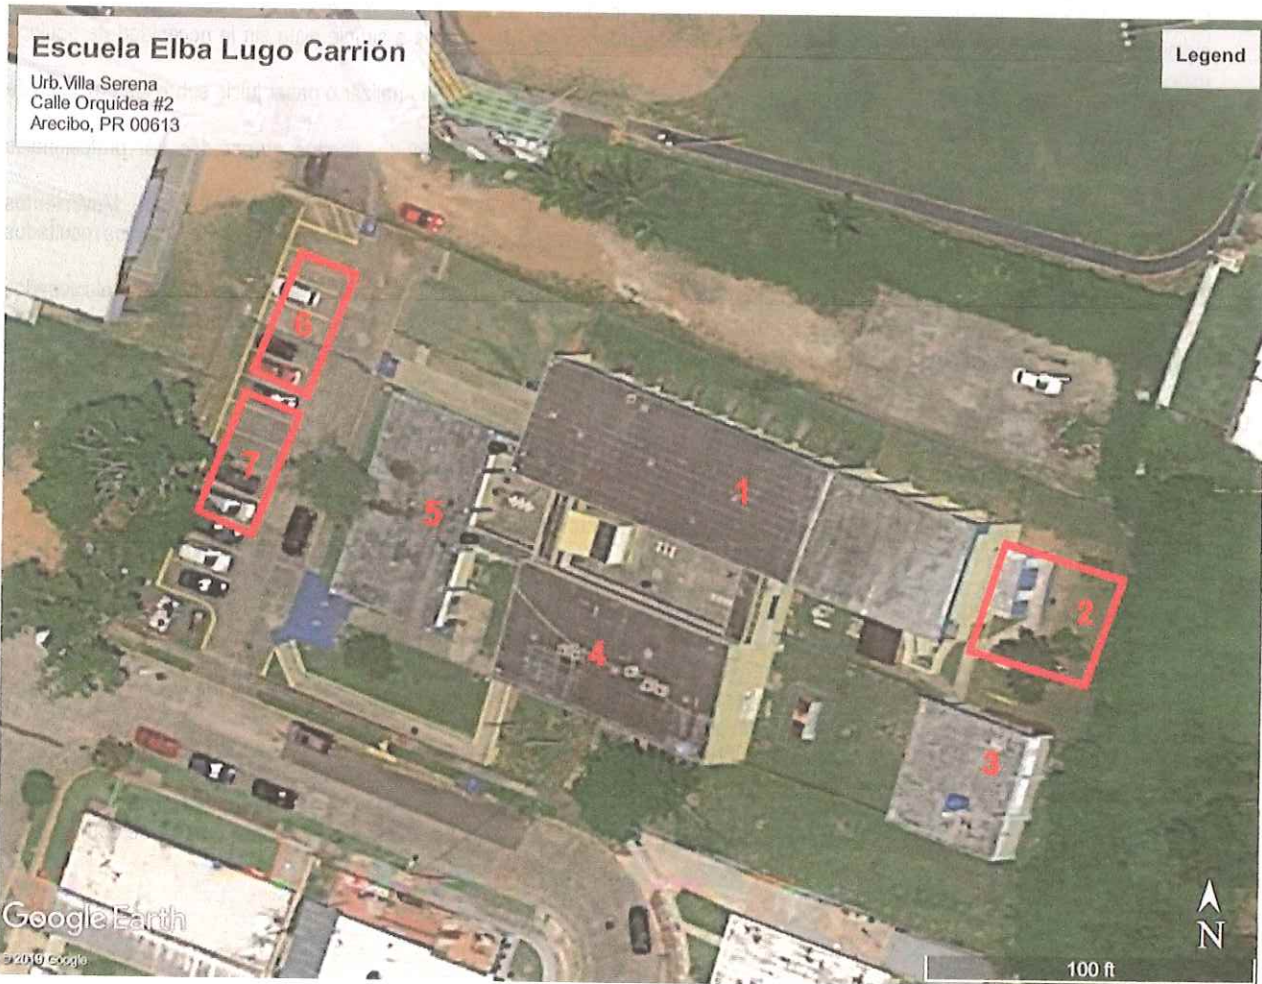
Plano de Sitio	Elba Lugo Carrión
Descripción:	Predio urbano con aproximadamente 4,000 m ² . Siete (7) estructuras independientes con aproximadamente 21,500 pies cuadrados de área bruta de piso.
