Α.	GENERAL INFORMATION		
1.	Street Address of the school:	Calle Muñoz Rivera final	
-	City: San Lorenzo	State: Puerto Rico	Zip:
2.	School Name: Luis Muñoz Rivera

3.	Date of inspection: 15 de enero de 2020		
4.	Inspector's Name: <u>José A. Cora Rodríguez / José</u>	ava Gil P.E. (Supervisor)	
В.	Inspector's Name: José A. Cora Rodríguez / José BUILDING SITE INSPECTION	Revisado 7 Tel	56

G. RECOMENDACIÓN AL SECRETARIO Departamento de Educación Dr. Eligio Hernández Pérez Secretario de Educación Hora: 3:30pm Código: AEP-8644 Fecha de Inspección: Escuela: Esc. Luis Muñoz Rivera 15 de enero de 2020 Municipio: San Lorenzo, PR. Abrir Escuela (Verde) Abrir Parcialmente la Escuela (Amarillo) No Abrir la Escuela (Rojo)

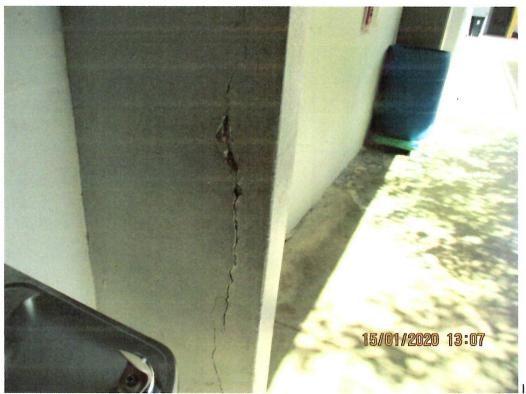
IMG. 1367

- Pared de bloques localizada en pasillo del comedor en fuente de agua. Condición preexistente. Recomendamos remover por seguridad la sección fracturada y reparar. Ver fotos IMG_1236.
- Fascia exterior de bajantes drenajes de techos. No daño estructural. Recomendamos remover y reparar. Ver foto IMG_1281.
- Techo alero pasillo frente salón 5 primer nivel. Acero de refuerzo corroído ocasiona el desprendimiento de hormigón. Condición preexistente. Recomendamos remover por seguridad el hormigón desprendido y reparar. Ver foto IMG_1367.
