CARTA DE TRAMITE

Escuela: Villa Capri Código: (62968)
Municipio: San Juan Fecha de: 10-enero-20
Inspección

OCULAR INSPECTION CHECKLIST

ANEXO A

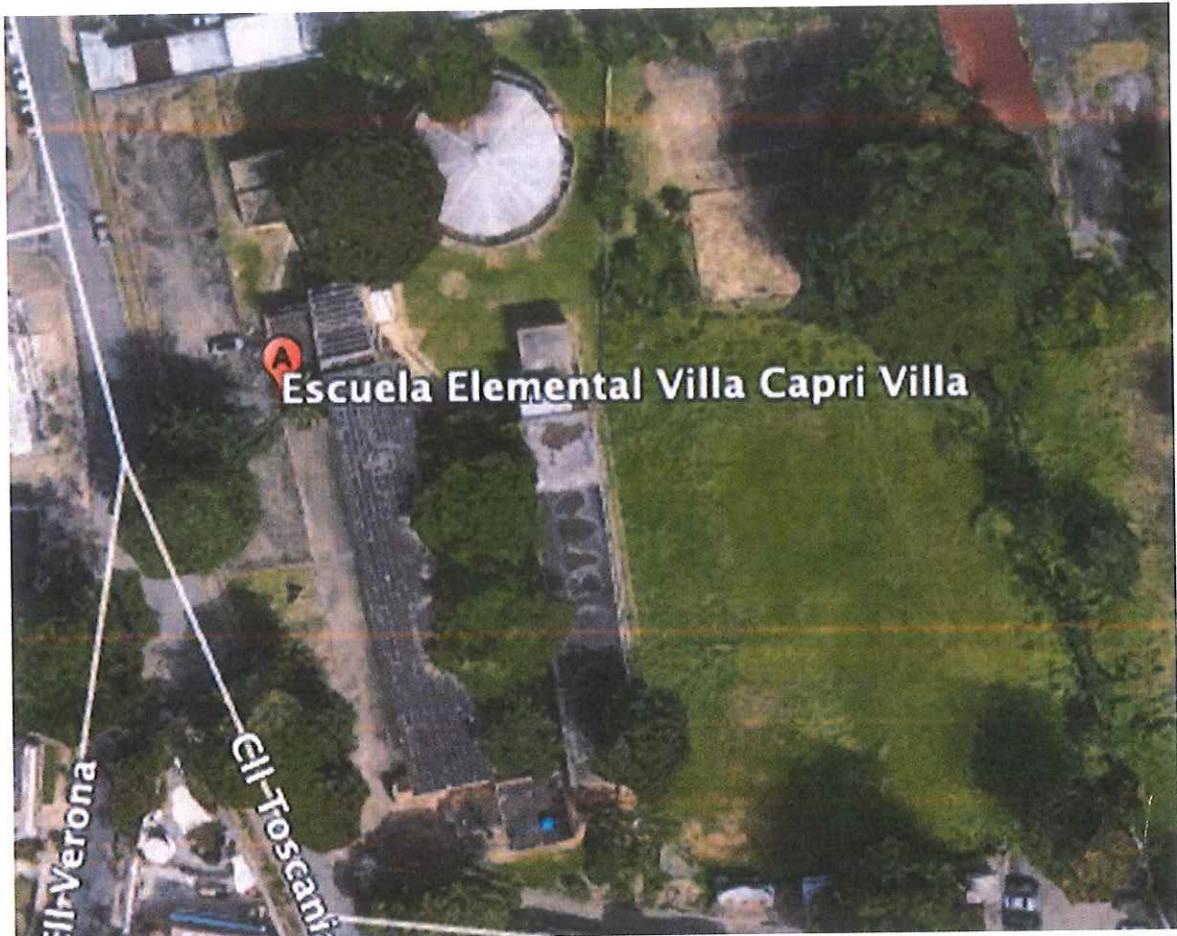
Plano de Sitio

Descripción: Vista aérea de la escuela / Plano de planta de escuela para identificar las áreas evaluadas.
