**GENERAL EARTHQUAKE DAMAGE INSPECTION CHECKLIST**

1. Street Address of the School: PR-486, Km 5.5 P.O. QUEBRADA  
 City: CAMUY State: P.R. Zip: 00627
2. School Name: SANTIAGO R. PALMER (PRIMARIA)  
K-8<sup>vo</sup>
3. Date of inspection: 31 | ENERO | 2020
4. Inspector's Name: FERNANDO E. FAGUNDO, PhD, PE

Escuela: Santiago R. Palmer Primaria  
(5-8vo)

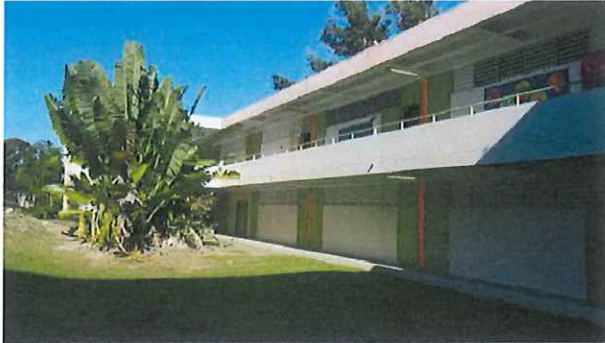
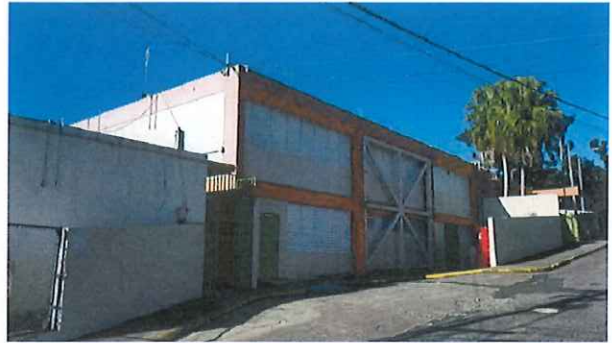
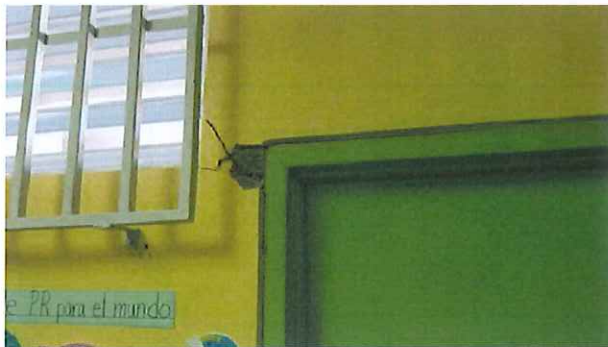
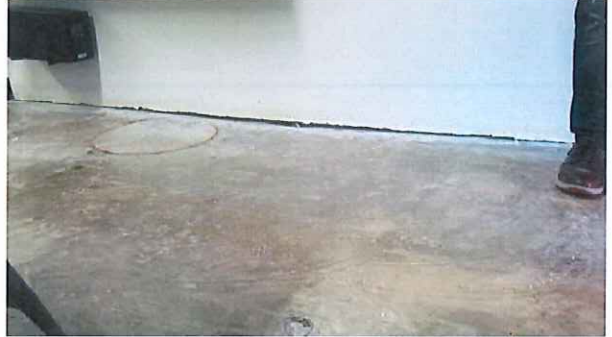
H. FOTOS

YES	NO	N/A
27.	Walls: (if yes, provide description and photos)	<input checked="" type="checkbox"/>	<input type="checkbox"/>	<input type="checkbox"/>
<i>NOTE</i>	a. Fresh cracking, buckling, spalling, or detachment of interior wall finish at corners of door and window openings? <i>NOTE: NON-STRUCTURAL DAMAGE TO MASONRY WALL AREA BETWEEN DOOR AND WINDOW OPENING.</i>	<input checked="" type="checkbox"/>	<input type="checkbox"/>	<input type="checkbox"/>

Comentarios: Grietas cerca de marcos de puertas y ventanas deben ser reparadas. El edificio fue remodelado con la adición de armazón externo en acero, esto protegió el edificio de problemas serios. Ver fotos  
Acentamiento de losa sobre piso, probablemente a problema de consolidación del terreno.  
Problema de corrosión en acero, debe ser reparado.
