CARTA DE TRAMITE

Escuela: **Bonifacio Alvarado**

Código: **(12518)**

Municipio: **Orocovis**

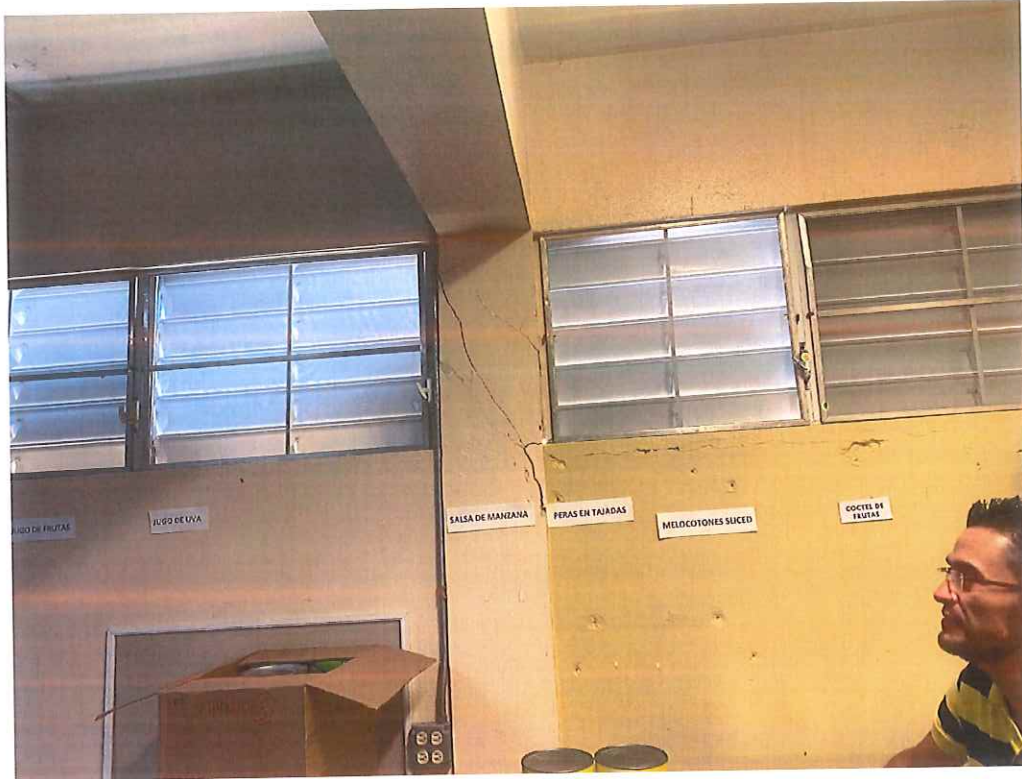
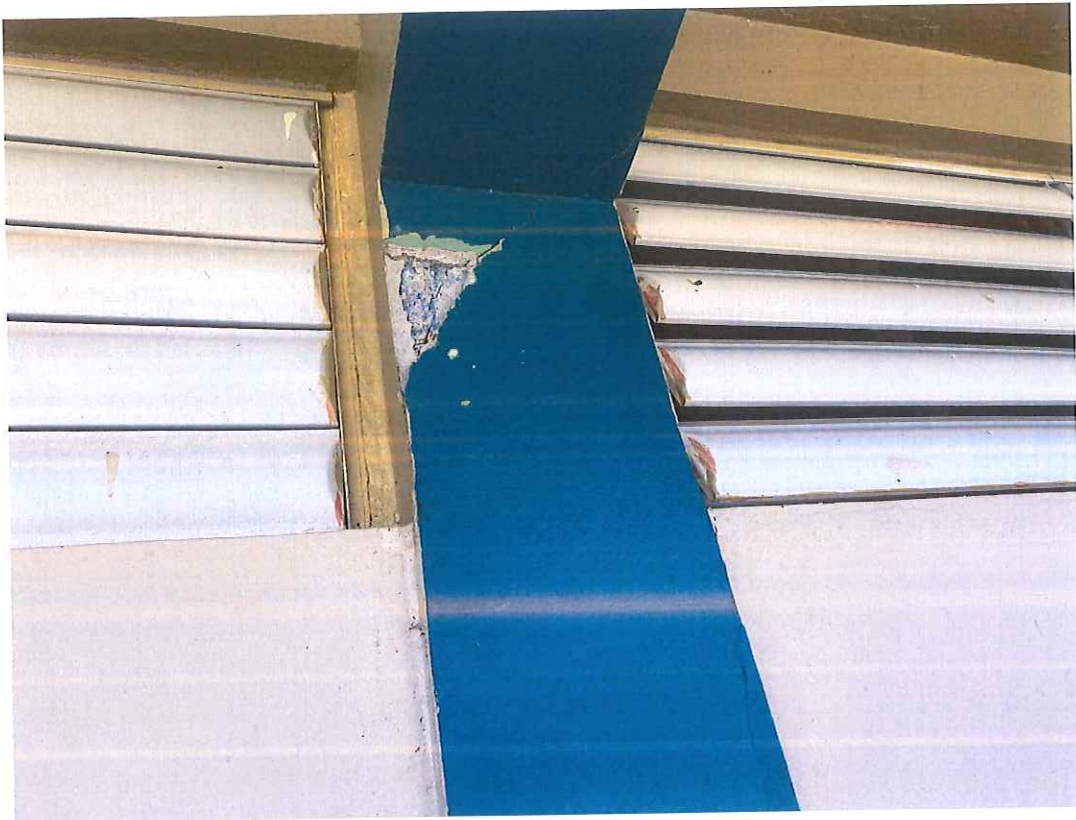
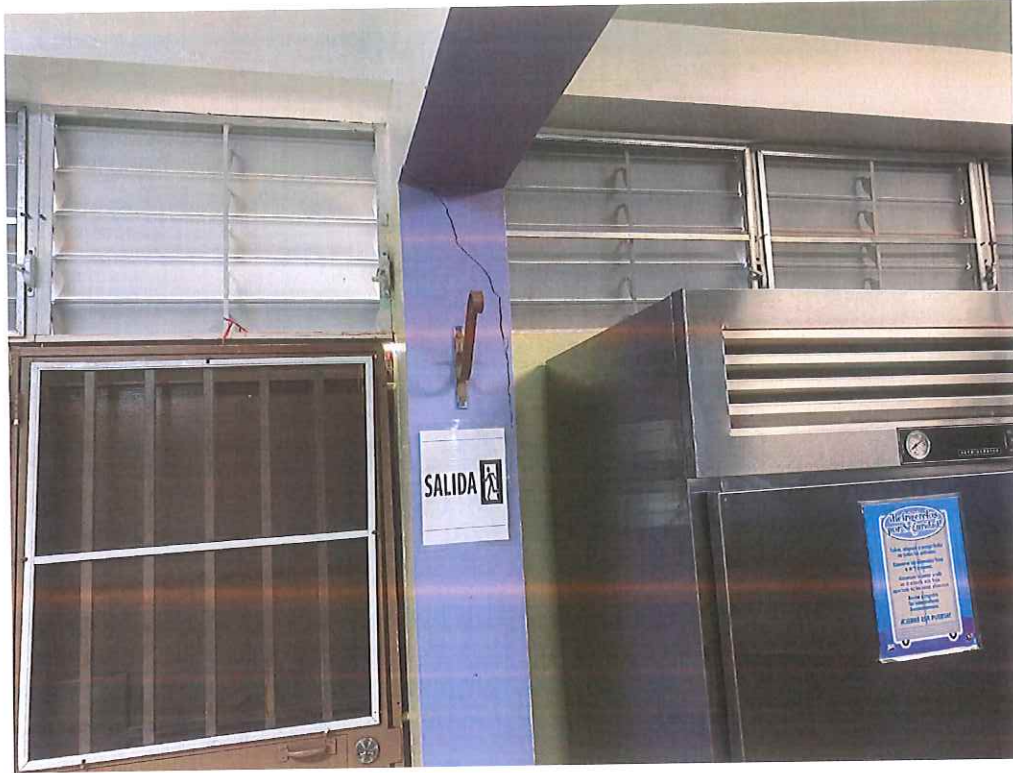
1. En el edificio del comedor se observó tres columnas cortas con grietas diagonales. Se recomienda el cierre total del plantel escolar. (FOTO 1, 2 Y 3).
2. En el edificio #3 se observó columnas que están localizada entre losa de piso fundacion que tienen problemas estructurales. Estas presentan acero expuesto y corroído. (VER FOTO 4,5 Y 6).
3. Edificio #5 se observó columnas con acero expuesto y vicios de construcción. (VER FOTO 7 Y 8)
