CARTA DE TRAMITE

Escuela: **Saltos Cabras (Angel Rafael Diaz Colon)** Código: **(12740)**

Municipio: **Orocovis** Fecha de: **16-Jan-20**
Inspección

OCULAR INSPECTION CHECKLIST

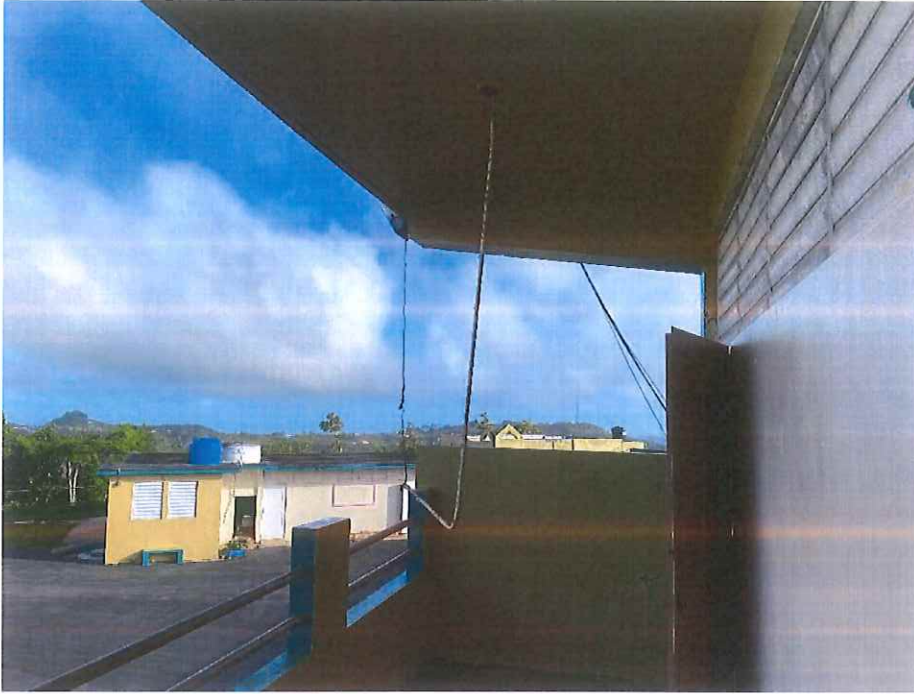
Foto 1: Tubo con cablería eléctrica está colgando en el pasillo del segundo nivel del edificio 3, frente al salón almacén.

1. Tubo con cablearía eléctrica está colgando en el pasillo del segundo nivel del edificio 3, frente al salón almacén. Se recomienda corrección inmediata. (VER FOTO 1)
2. Problemas de filtraciones en los techos del plantel escolar. Daños preexistentes. (VER FOTOS 2 Y 3)
3. En el exterior del comedor localizado en edificio #2, se observaron columnas con grietas preexistentes en el empañetado. Estas grietas fueron causadas por una penetración de clavo en la esquina de la columna. Estas columnas fueron verificadas en el interior del comedor y no presentan daños. Estas grietas no fueron causadas por los sismos ni representa daños estructurales.

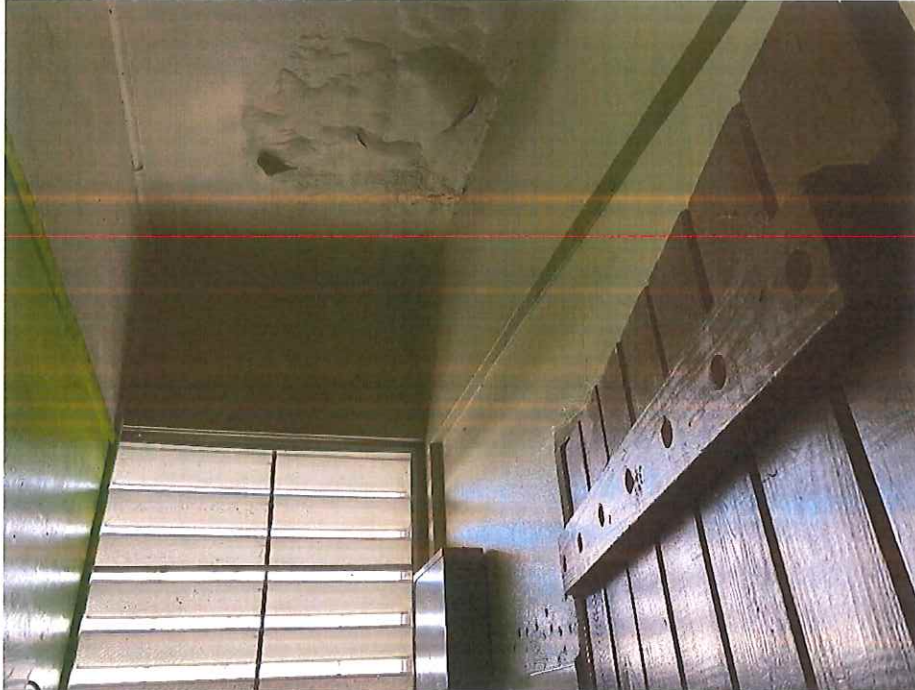
Foto 2: Problemas de filtraciones en los techos del plantel escolar.

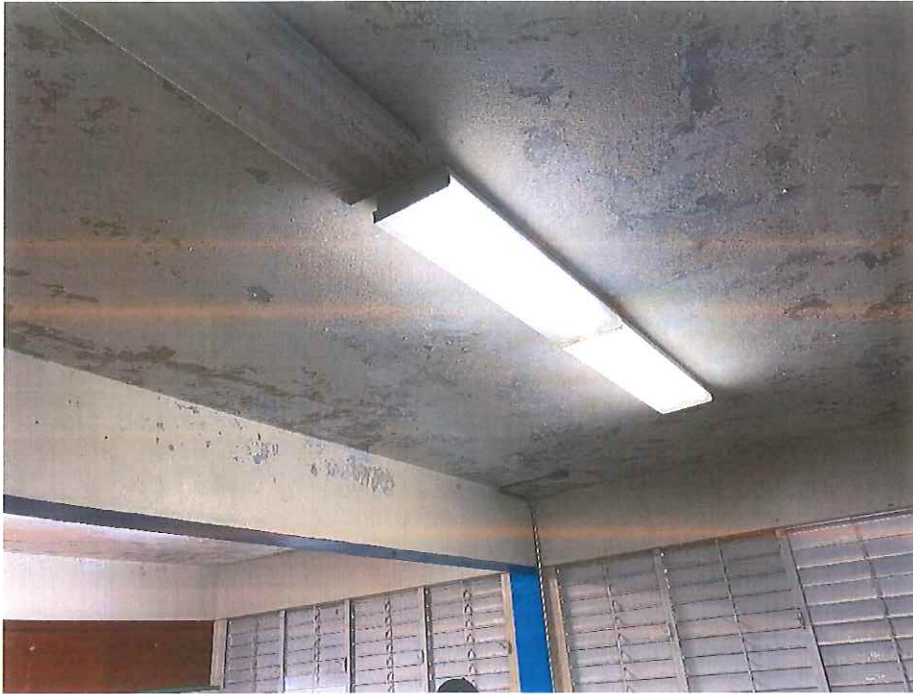
Foto 3: Problemas de filtraciones en los techos del plantel escolar.

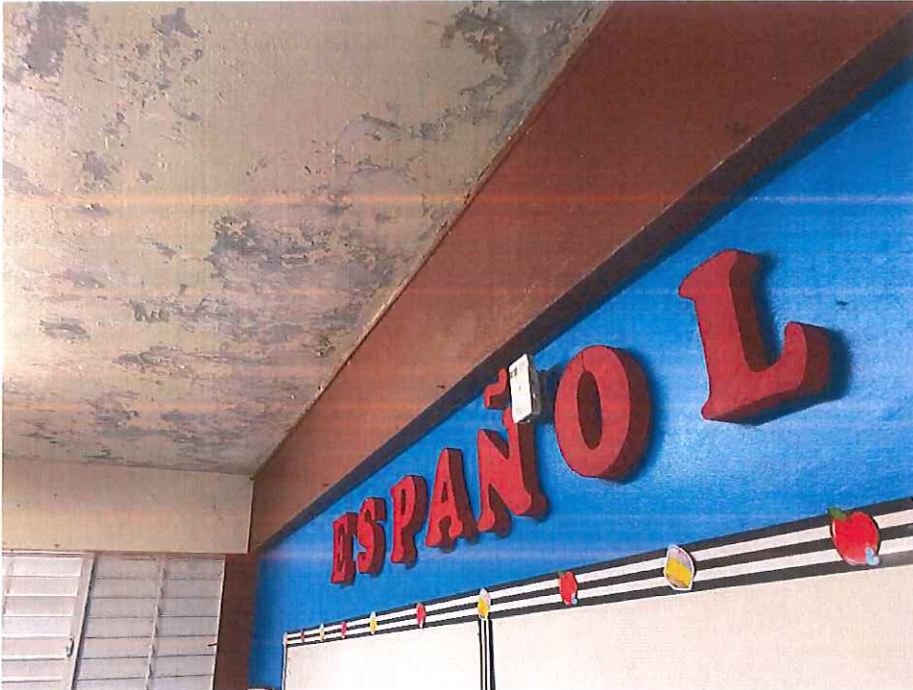
Foto 4: Problemas de filtraciones en los techos del plantel escolar.

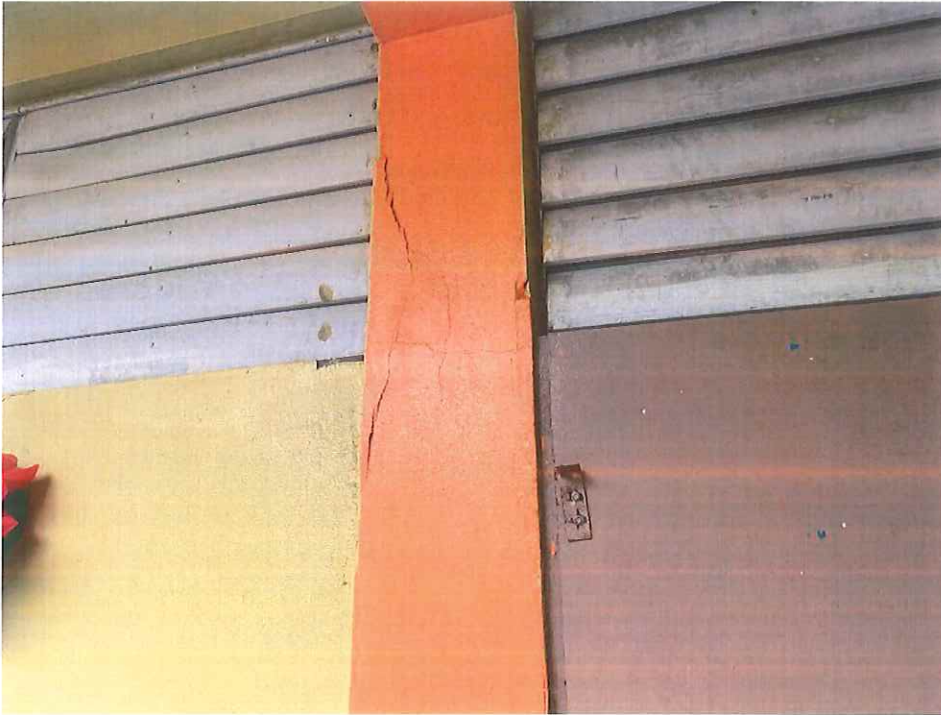
Foto 5: Grieta preexistente en el empañetado de columna del comedor la cual fue causada por penetración de clavos en la esquina de esta.

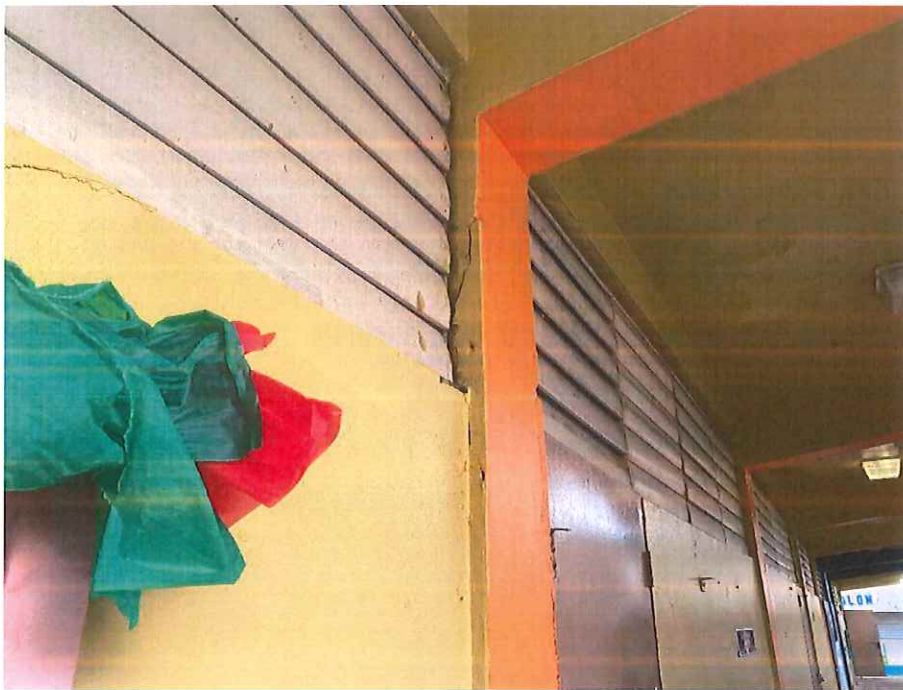
Foto 5: Grieta preexistente en el empañetado de columna del comedor la cual fue causada por penetración de clavos en la esquina de esta.

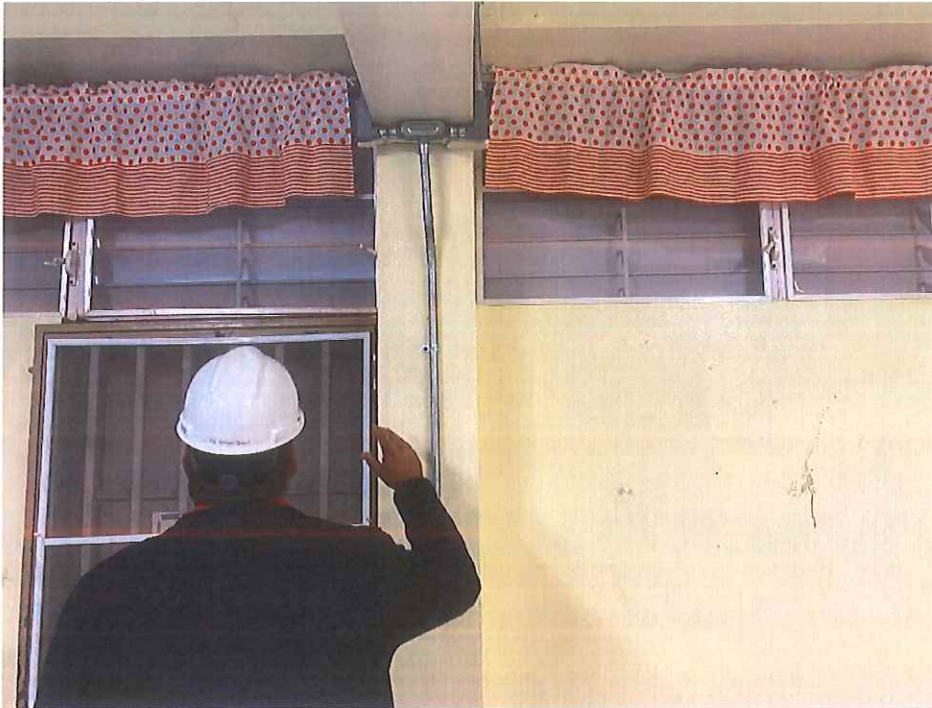
Foto 6: Interior de la columna que en el exterior tiene la grieta preexistente por penetración de clavo donde no se observa ningún daño estructural.
