Escuela: Alberto Melendez Torres

Municipio: Orocovis

Fecha de:
Inspección 15-Jan-20

OCULAR INSPECTION CHECKLIST

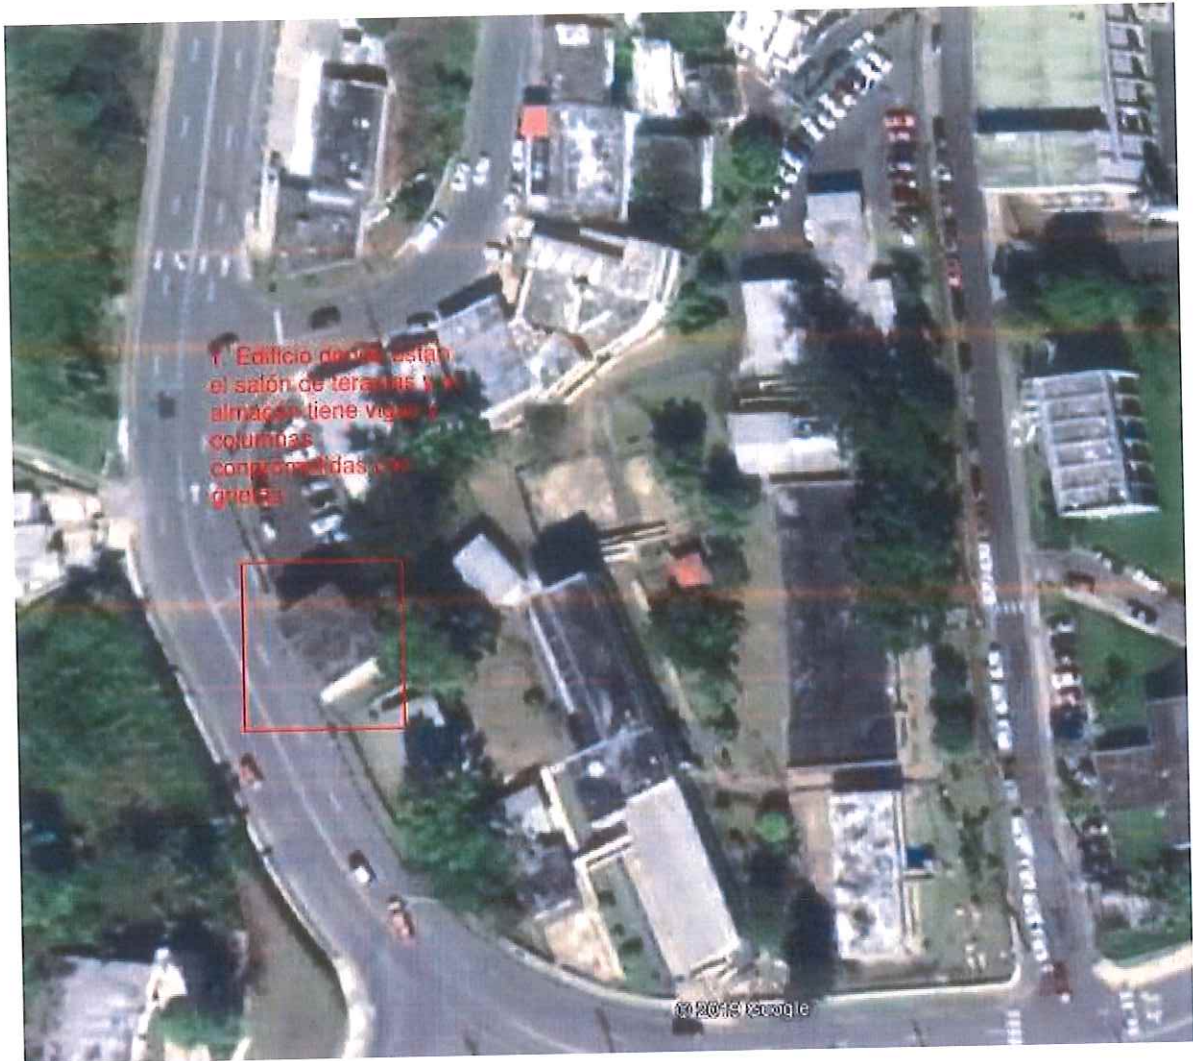
Edificio donde están el salón de terapias y el almacén tiene vigas y columnas comprometidas con grietas. Este edificio no estaba en uso por lo que se recomienda se mantenga cerrado y se acordone el área antes del comienzo de clase.

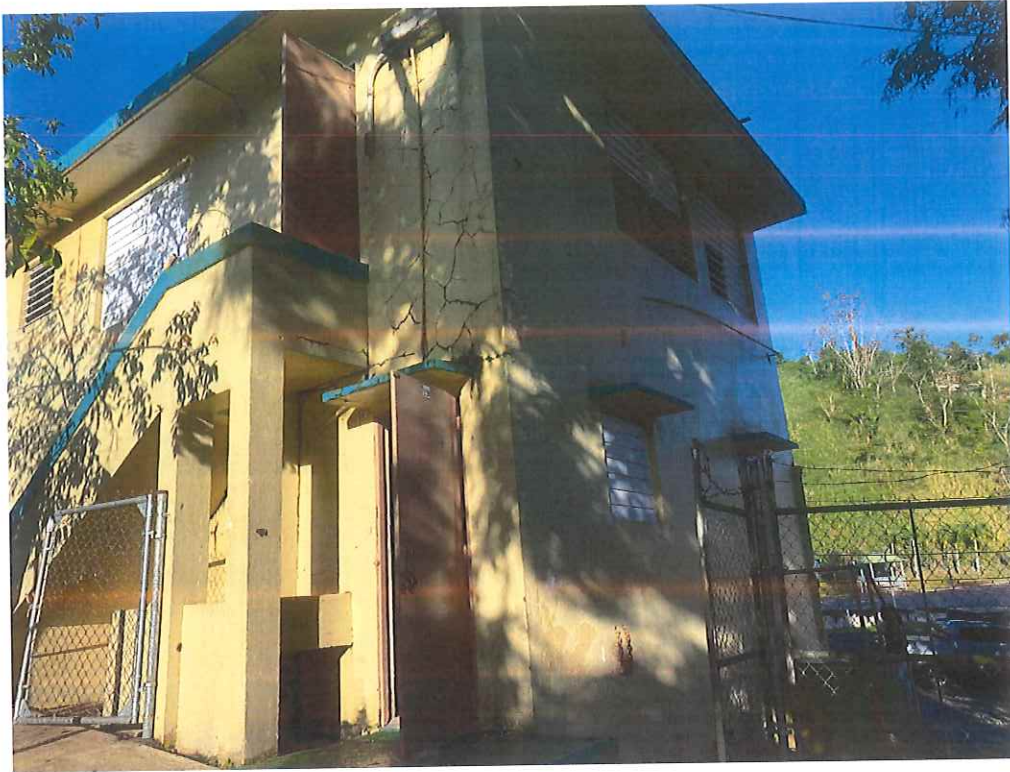
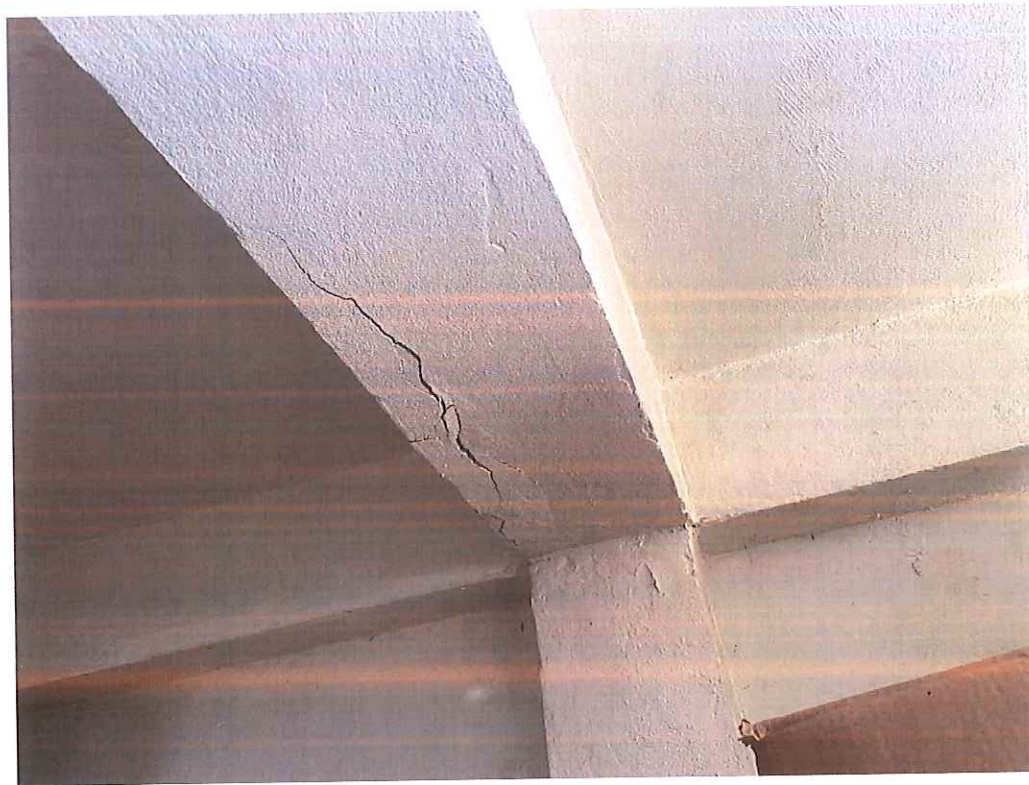
1. Edificio donde estan el salón de terapias y el almacén tiene vigas y columnas comprometidas con grietas. Este edificio no estaba en uso por lo que se recomienda se mantenga cerrado y se acordone el área antes del comienzo de clase.

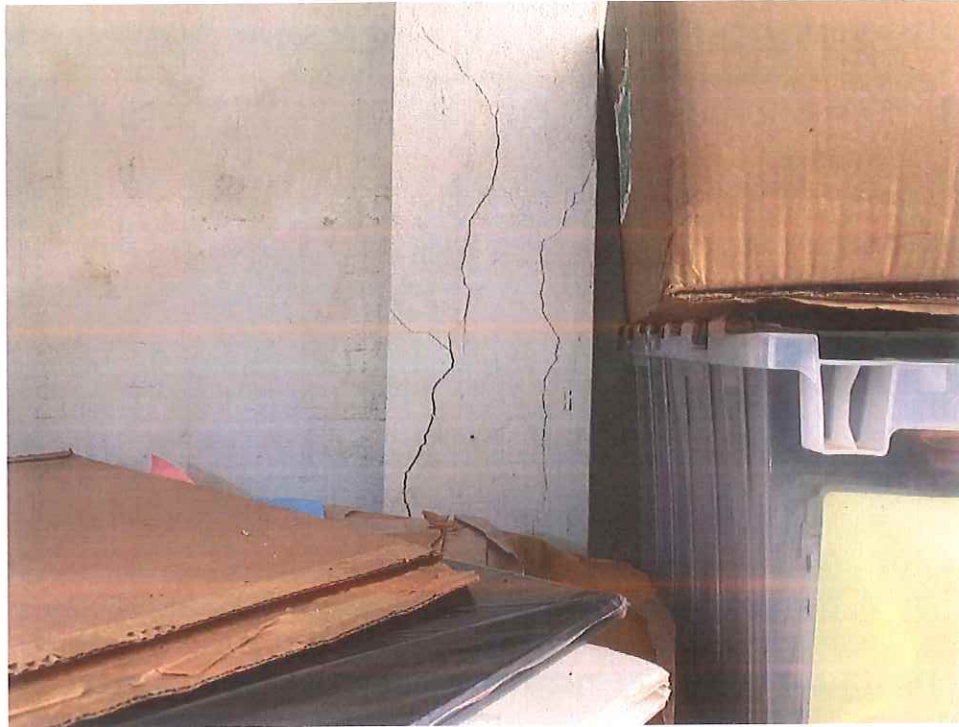
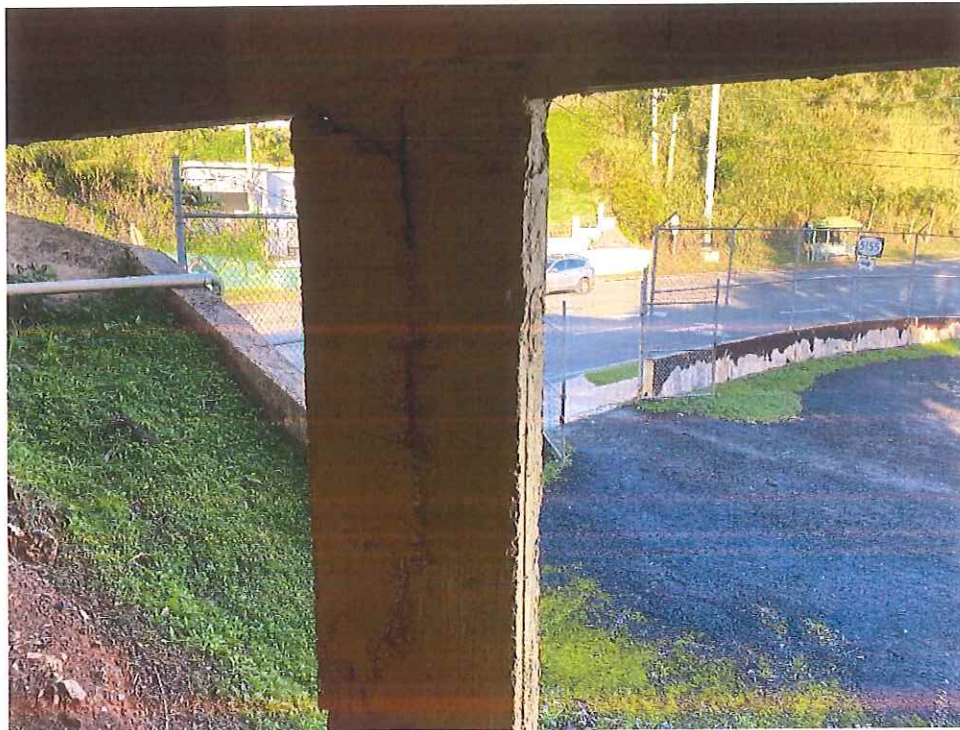
Edificio donde estan el salón de terapias y el almacén tiene vigas y columnas comprometidas con grietas. Este edificio no estaba en uso por lo que se recomienda se mantenga cerrado y se acordone el área antes del comienzo de clase.
