## CARTA DE TRAMITE

Escuela:	Ramon T Rivera (Lajitas)	Código:	20545
Municipio:	Barranquitas	Fecha de Inspección:	26-enero-2020
Escuela:

# OCULAR INSPECTION CHECKLIST

## G. RECOMENDACIÓN AL SECRETARIO

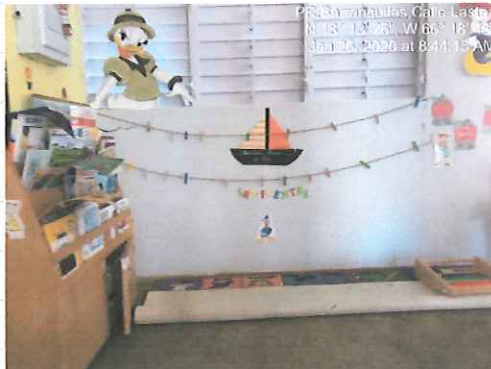
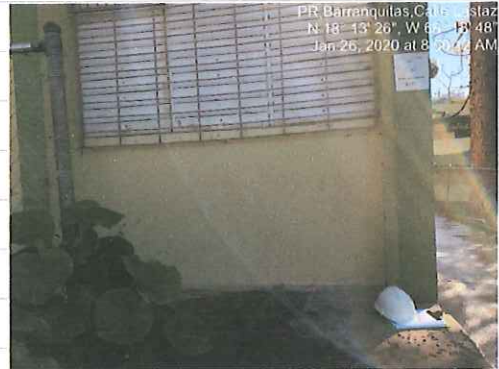
De la inspección visual, en uno de los edificios de un nivel se encontró que una de las paredes que esta por debajo de las ventanas tenía una grieta significativa. La pared no es un elemento estructural y no representa un riesgo para la integridad estructural del edificio. Si embargo, se le recomendó al director reubicar el salón a otra área del plantel de la escuela. Ver Fotos.
