## CARTA DE TRAMITE

Escuela: NICOLÁS AGUAYO ALDEA Código: 20594  
Municipio: CAGUAS Fecha de Inspección: 1/13/2020

## GENERAL EARTHQUAKE DAMAGE INSPECTION CHECKLIST

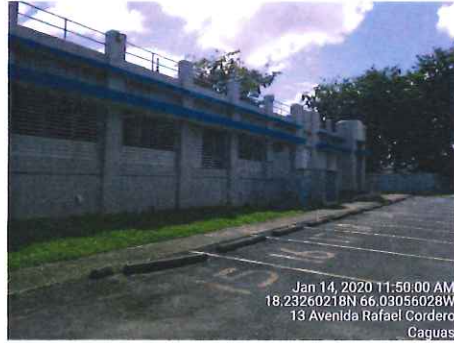
Estructura principal en excelentes condiciones .  
 Cafeteria con diseo de columna corta, no hay grietas . Mantener en observacion.  
 \_\_\_\_\_  
 \_\_\_\_\_  
 \_\_\_\_\_  
 \_\_\_\_\_  
 \_\_\_\_\_  
 \_\_\_\_\_  
 \_\_\_\_\_  
 \_\_\_\_\_  
 \_\_\_\_\_

Figura 1:Edificio escolar con columna corta.
