## CARTA DE TRAMITE

Escuela: **Carlos Zayas**

Municipio: **San Lorenzo**

# OCULAR INSPECTION CHECKLIST

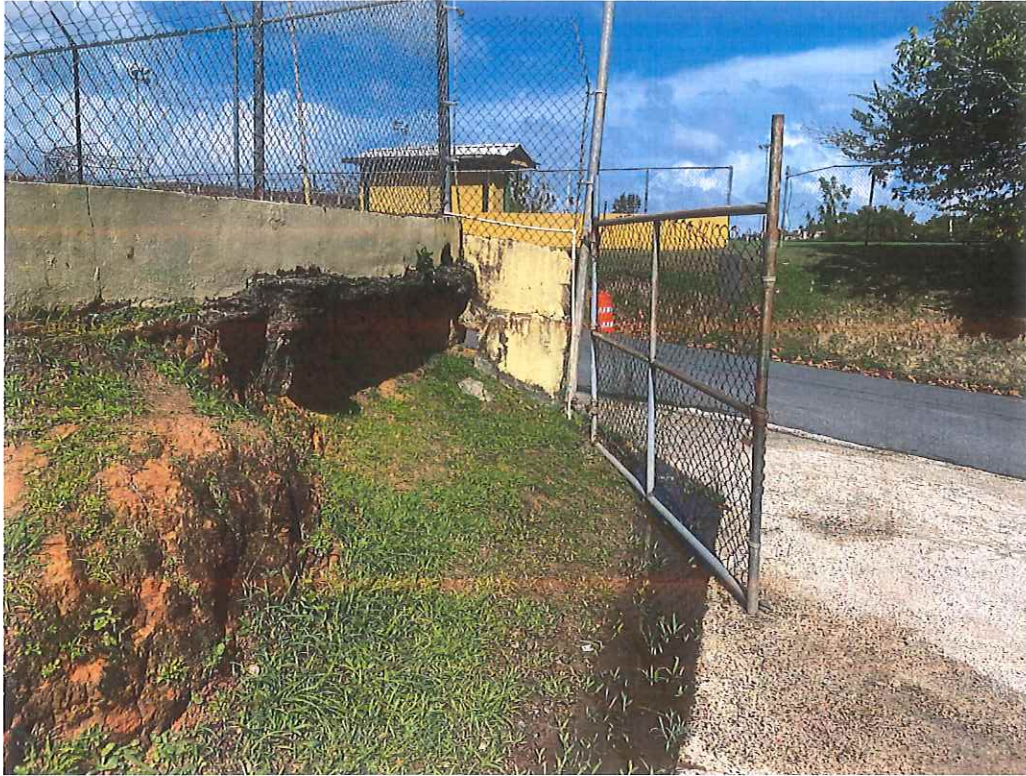
Foto 1

1. Verja que corre desde entrada de la parte de abajo del plantel, por detras de salones de kinder tiene pedasos sueltos que pudieran atribuirse a los movimientos sismicos. Tambien la misma tiene la zapata expuesta lo cual es una condición pre-existente. Se recomienda acordonar toda el área hasta con una distancia de 5' a cada lado hasta que se repare. (VER FOTO 1 Y 2) 2. Varios edificios del plantel tienen problemas de filtraciones pre-existente. (VER FOTO 3 Y 4) 3. Baños localizados un el centro del plantel tiene lozetas de pared sueltas. Esta condición es pre-existente. (VER FOTO 5)
