CARTA DE TRAMITE

Escuela: Antonio Valero Bernabé

Municipio: Fajardo

OCULAR INSPECTION CHECKLIST

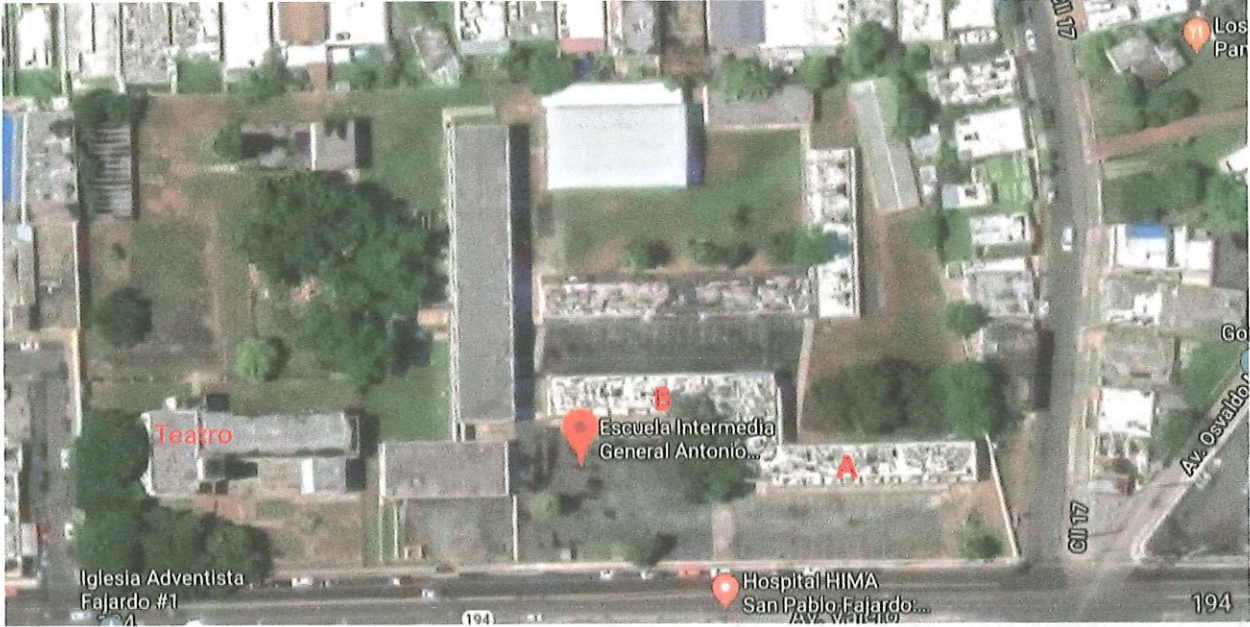
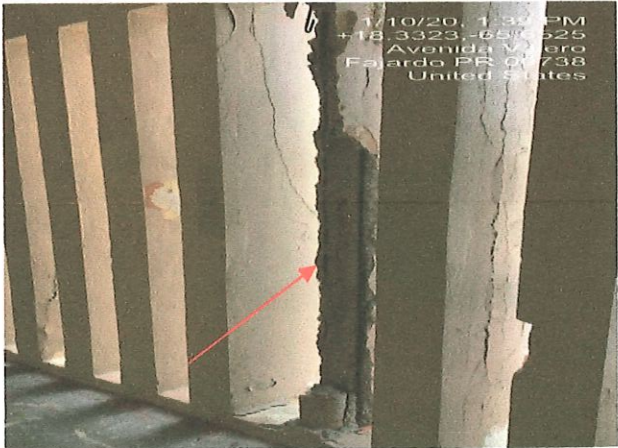
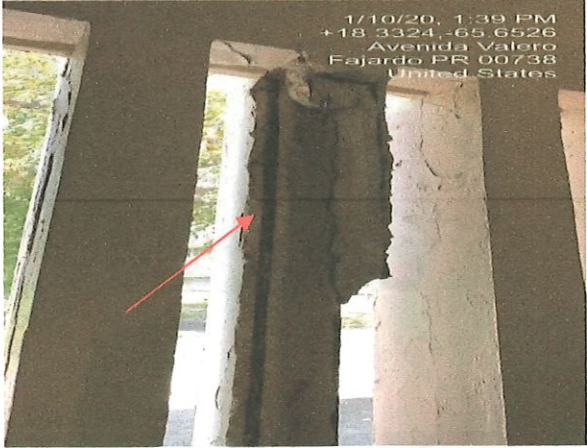
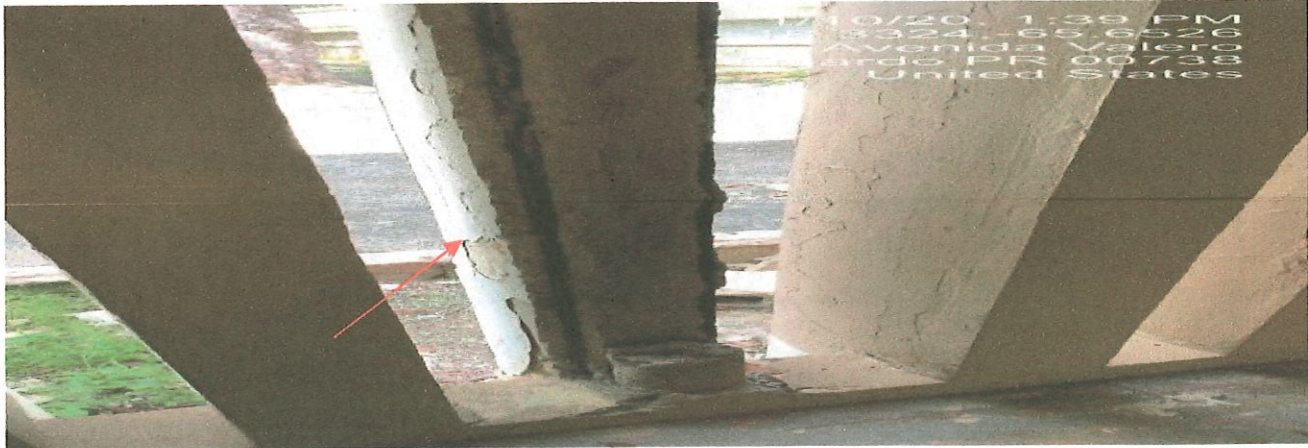
Fotos Esc. Antonio Valero Bernabé, Fajardo P.R.

j. Collapse, partial collapse, or separation of masonry veneer?	<input type="checkbox"/>	<input checked="" type="checkbox"/>	<input type="checkbox"/>
k. <u>Severe cracking</u> , separations, or offsets at building irregularities? <i>En vigas 1^a Nivel edificacio B</i>	<input checked="" type="checkbox"/>	<input type="checkbox"/>	<input type="checkbox"/>

Comentarios: Se recomienda cerrar los edificios A y B según identificados en las fotos ya que el edificio B presenta múltiples grietas en la viga oeste en el primer nivel comprometiendo estructuralmente la integridad del edificio. En el edificio A se observó varias columnas que tenían de refuerzo expuesto en el segundo nivel adicional, estas columnas perdieron área seccional. En el edificio donde se encuentra el teatro solo se inspeccionó dicha área ya que no tenían acceso al resto del edificio.

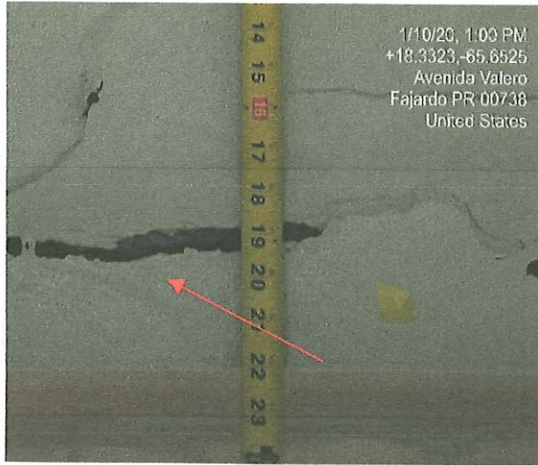
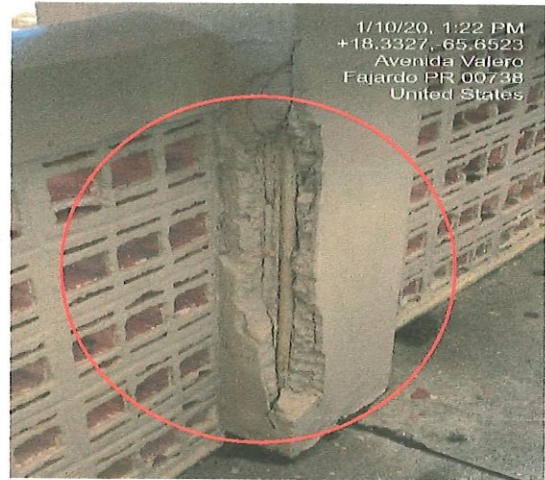
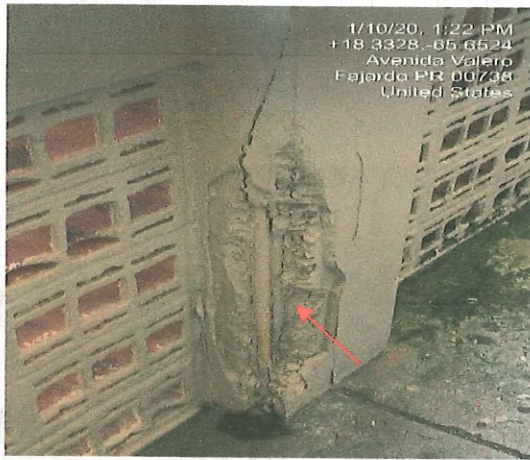
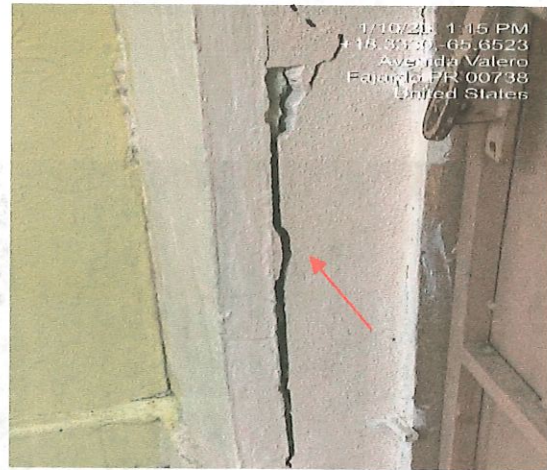
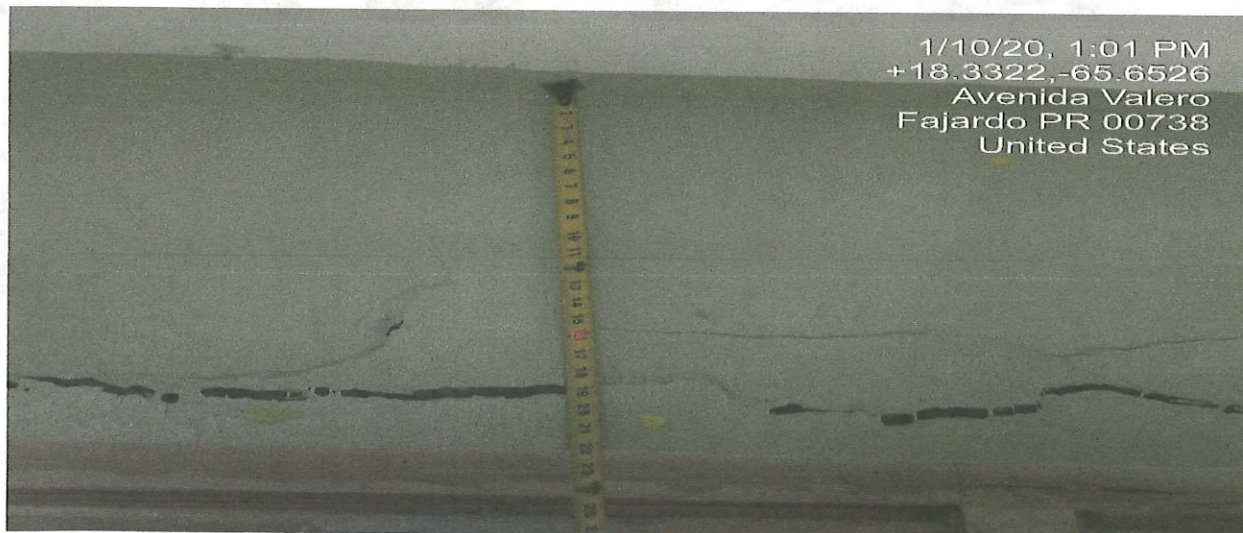
Fotos Esc. Antonio Valero Bernabé, Fajardo P.R.

g. Others damage <i>Se observaron columnas en el 2º N.ivel del edificio Acon Acero de refuerzo expuesto.</i>	<input checked="" type="checkbox"/>	<input type="checkbox"/>	<input type="checkbox"/>
