CARTA DE TRAMITE

Escuela: PEDRO MOCZÓ BANIET Código: 60418

Municipio: CAROLINA Fecha de Inspección: 1/14/20

GENERAL EARTHQUAKE DAMAGE INSPECTION CHECKLIST

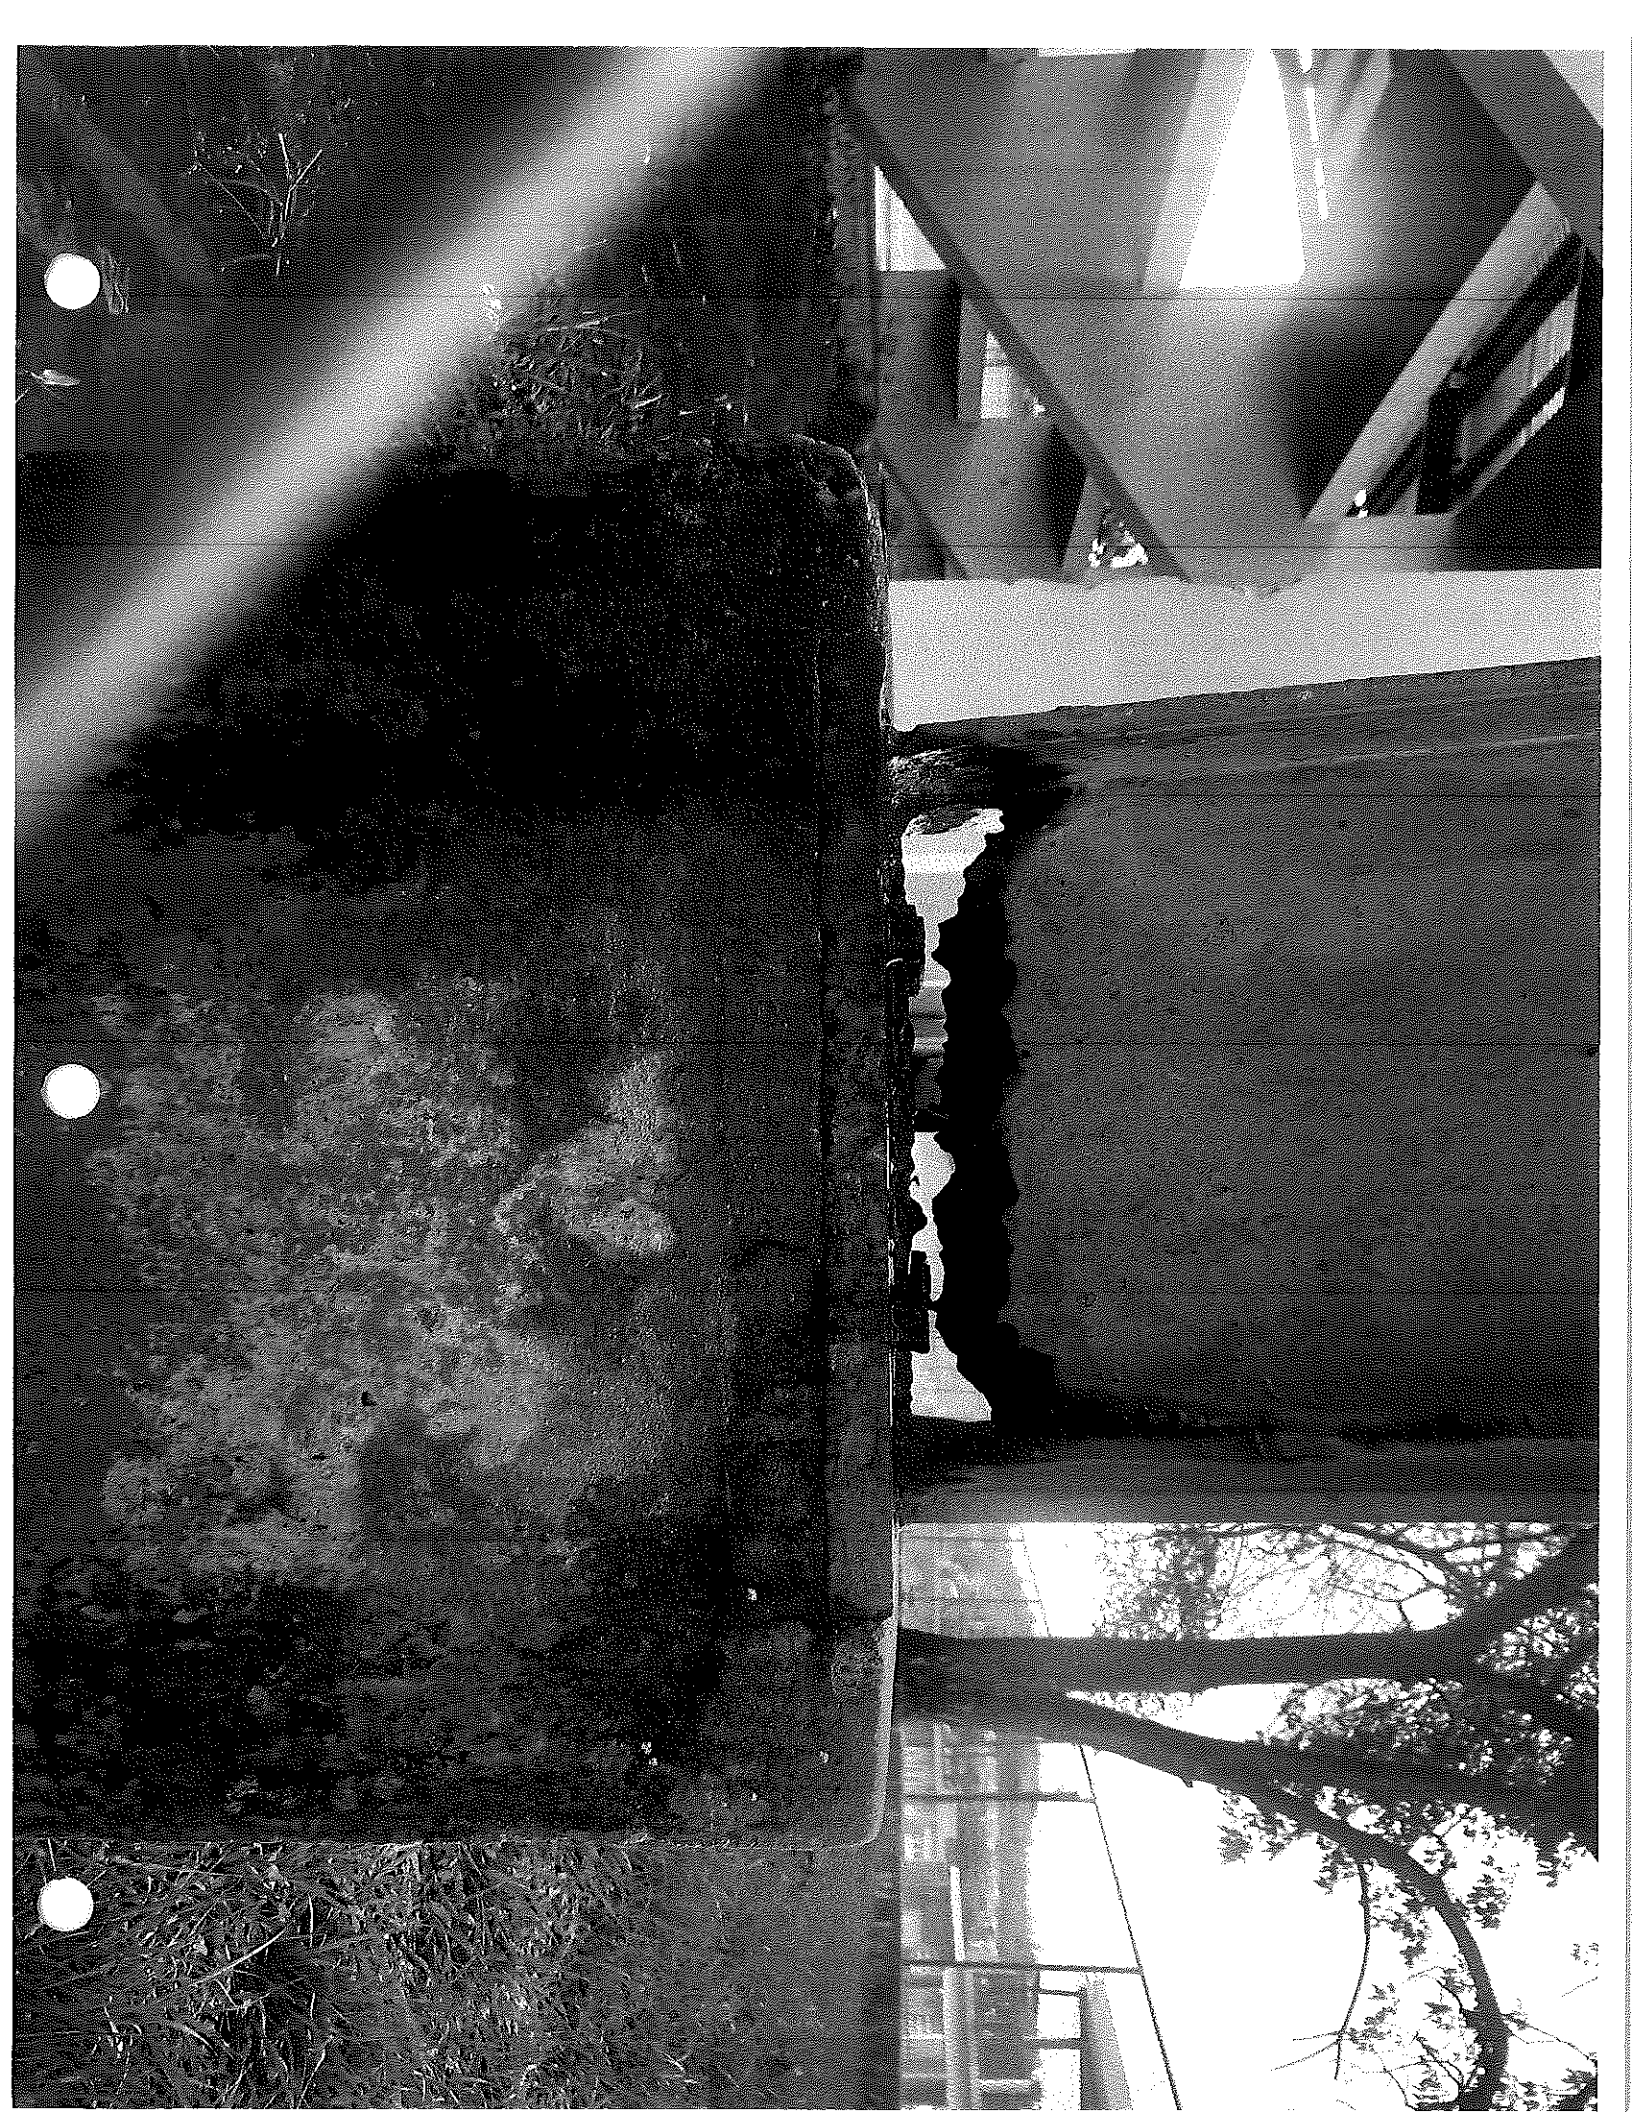
En la estructura de metal que cubre la cancha de baloncesto se observa un deterioro producido por corrosion en la base de la mayoría de sus 12 columnas. En algunos casos se ha producido la perdida total de la seccion de la columna en su base. Vea foto anejo.

Recomendamos discontinuar su uso, aislar su acceso y efectuar un estudio detallado por un ingeniero estructural.
